FULL RESERVE FUND STUDY

*LAKE PARK CONDOMINIUMS
RALEIGH, NC*

Prepared by:
**CRITERIUM – GILES ENGINEERS
1150 SE MAYNARD ROAD, SUITE 220
CARY, NC 27511
(919) 465-3801
NC LIC. No. C-2871**

DECEMBER 28, 2014

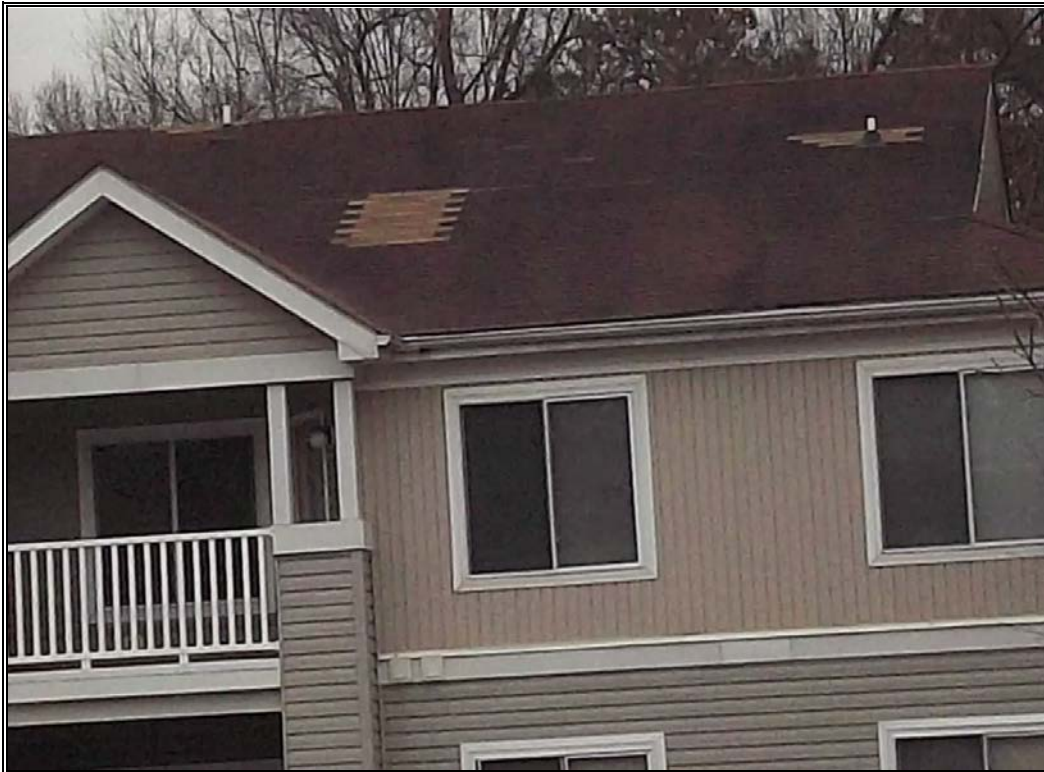
3

Close-up view of patched roof shingles on Building 1430 – typical of several buildings

Typically we anticipate 3-Tab roof shingles to have an expected useful life of approximately 20 years. Seven buildings were re-roofed in 2014 (after approximately 17 years of service). The remaining roofs generally appeared to be in poor-to-fair condition with areas of patched shingles observed. We have reviewed the Roofwerks roof condition report from December 2013 and generally agree with their expected lives for each building roof. We have allocated funds to replace six more roofs in 2015 and the remaining five building roofs in 2017. Replacement of roofs over the seven buildings with recently installed roof shingles should not be required until approximately 2034.

A re-roofing sequence should include removal of the existing shingle surfacing, replacement of any inadequate roof sheathing, replacement of any damaged flashing, and replacement of drip edge components. We strongly recommend that any re-roofing project closely follow procedures

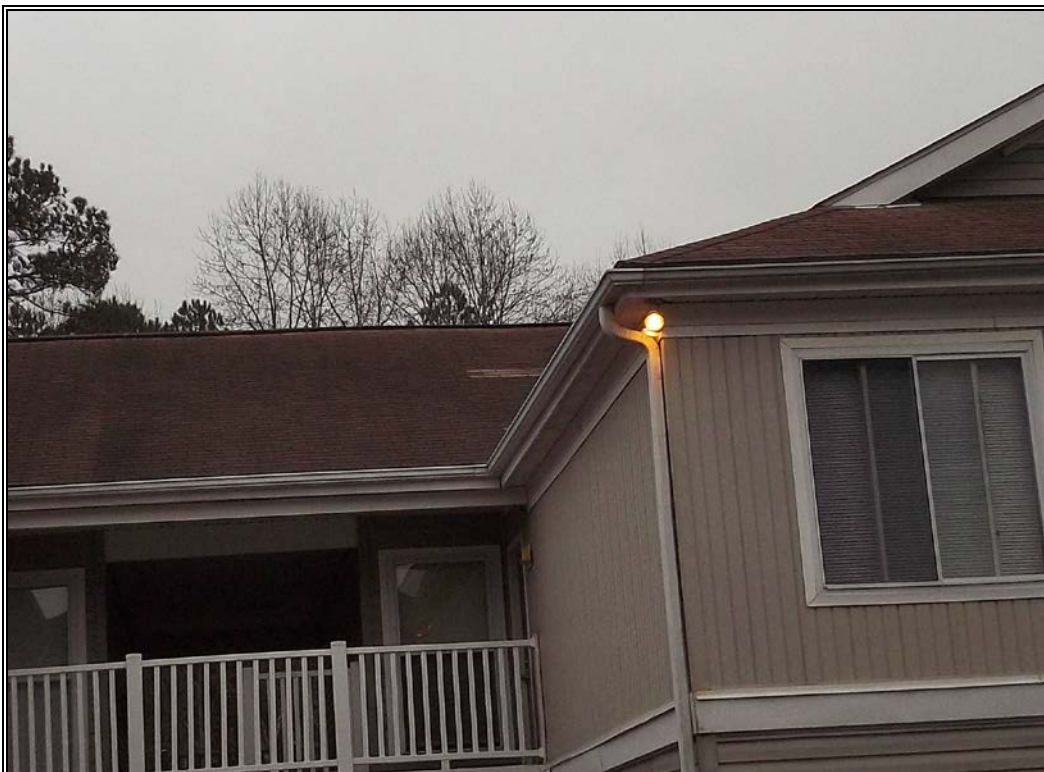
View of another building roof with patched shingles

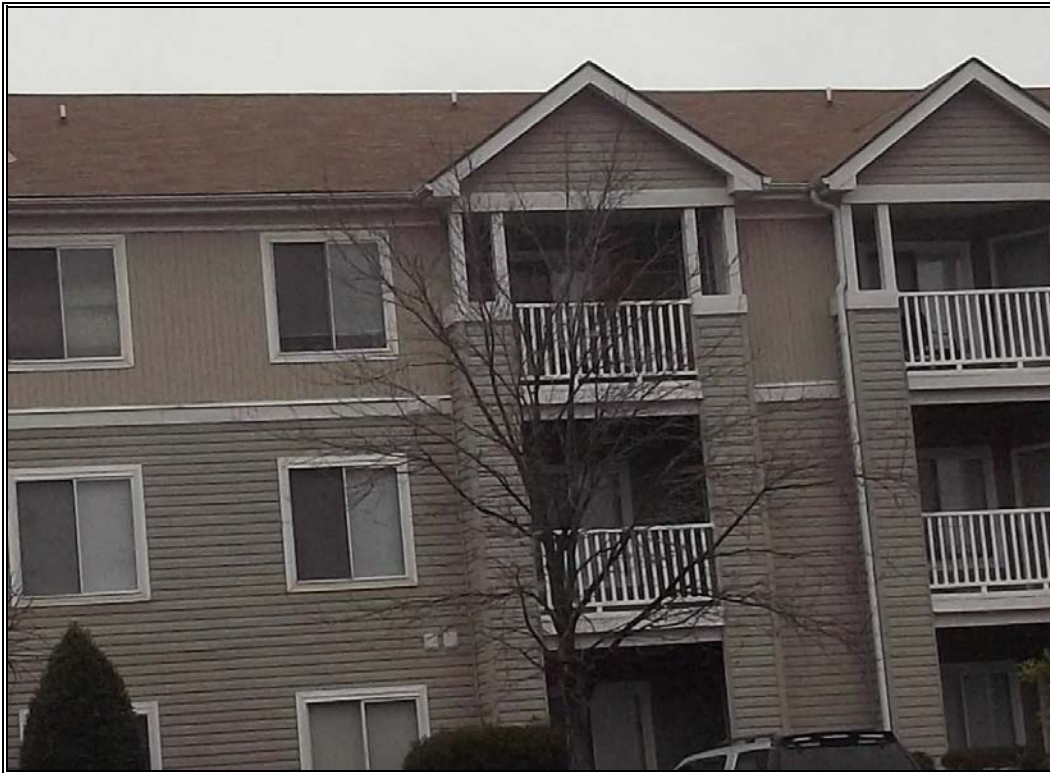
Photo Number
5

Description:
Note building roof
shingles are
relatively new

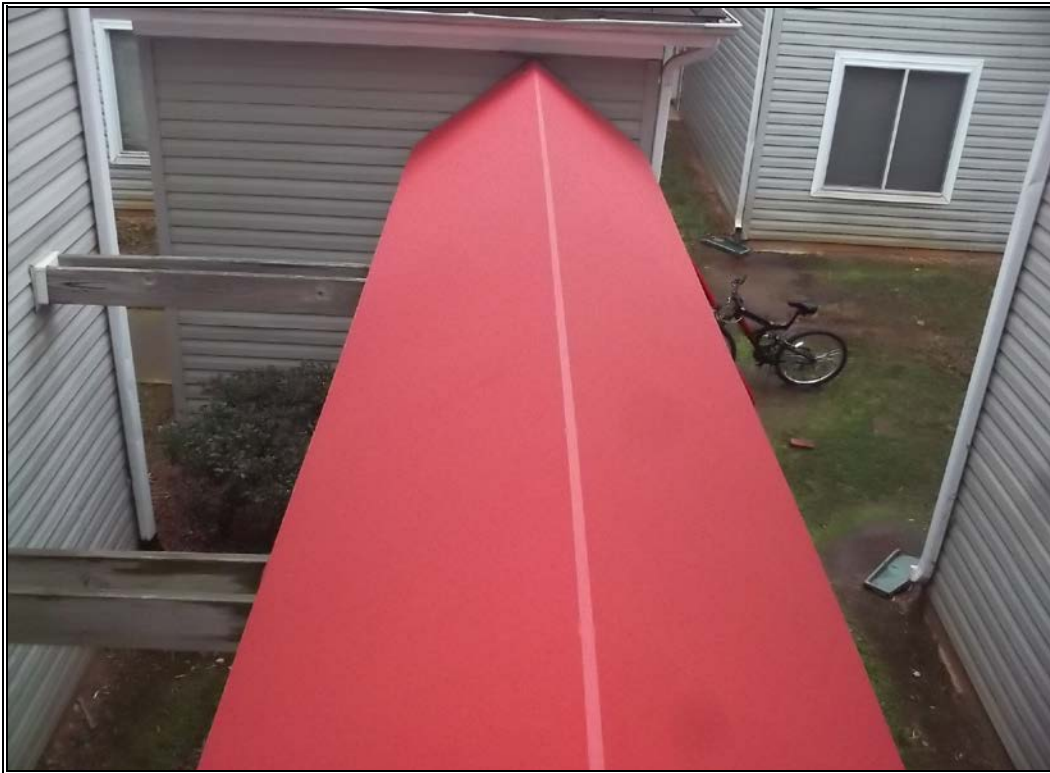
Photo Number
7

The canopies at the building entrances have been replaced since original construction and appeared to be in relatively good condition. These type canopies typically show signs of wear and discoloration in approximately 10-years and we have allocated funds to replace all canopies in 2020 and on a 10-year cycle.

Description:
Note typical grade level entrance canopy

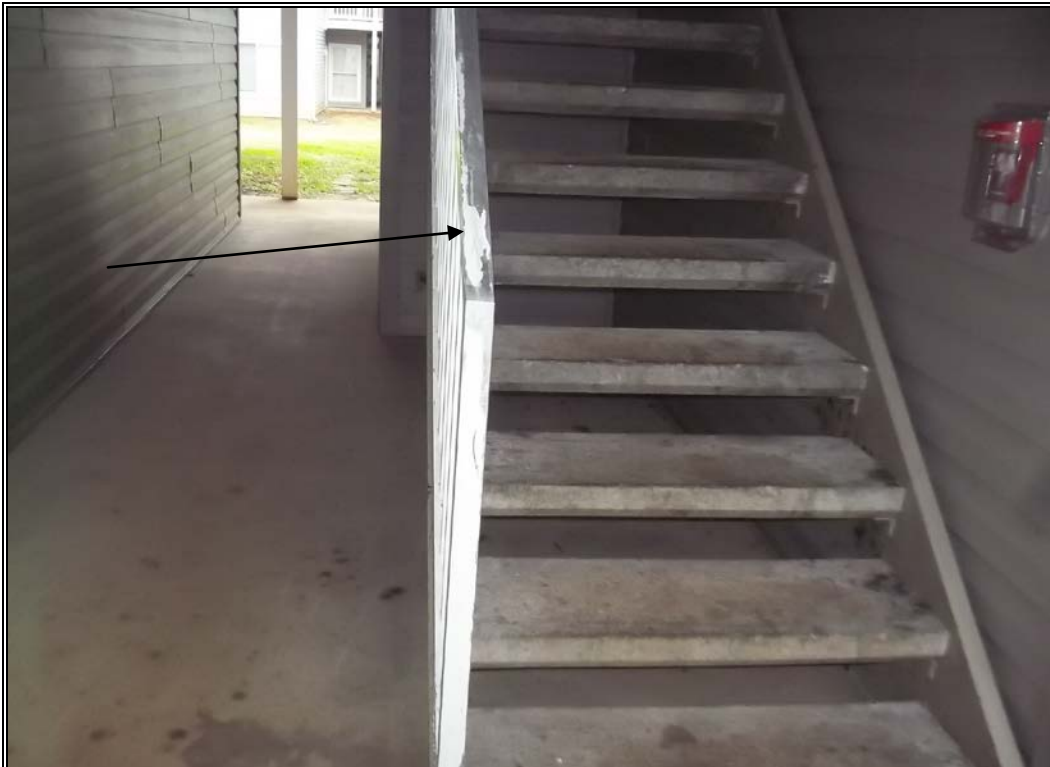
Photo Number
8

Concrete treads in the open riser stairways appeared to be in satisfactory condition. Typically these treads will be replaced from the Maintenance budget if individually damaged and we have not included funds from the reserve account for replacement of treads. The metal railings at each stairway should not require replacement during the term of this analysis. However, we noted peeling and missing paint on many sections of railings and have allocated funds to paint all the stairway railings in 2016 and on a 10-year cycle.

Description:
View of typical staircase with open risers, concrete steps and metal railing (railing needs painting)

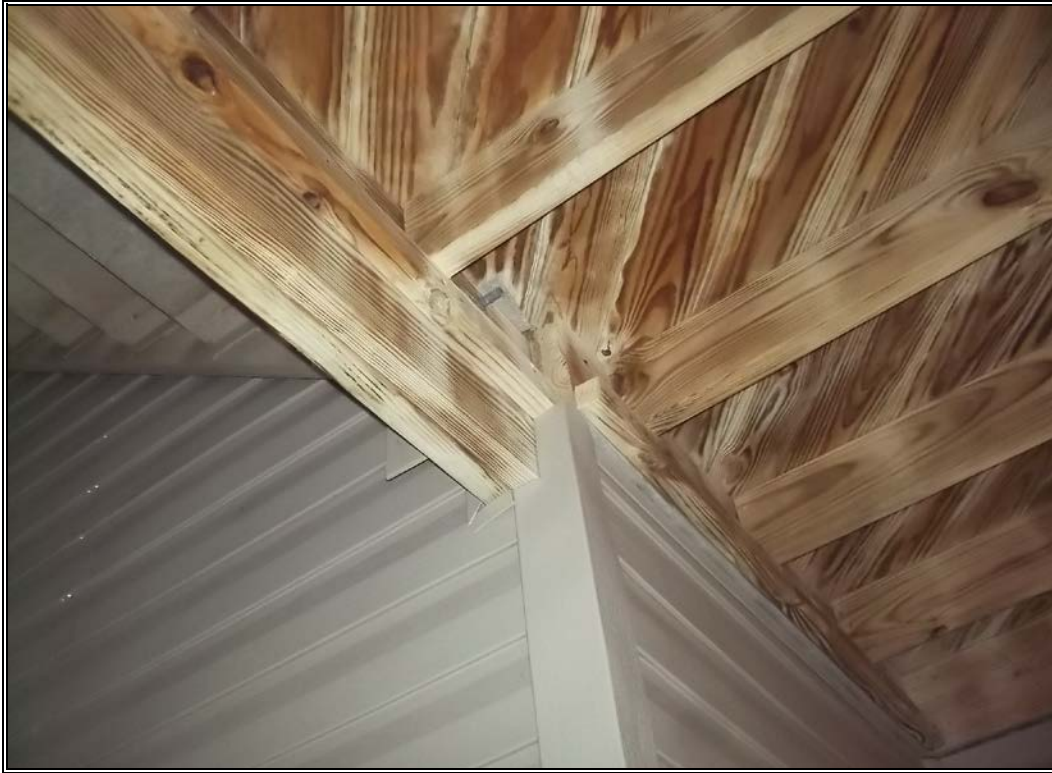
Photo Number
9

The building wood decking and breezeway framing generally appeared to be in good condition. Because these components are not under direct sunlight or exposure to the elements, the expected life of the wood exceeds the life of typical wood decks. We do not anticipate full structural replacement of the stairs or breezeways will be required in the next 20 years. However, we have provided an allowance per building for decking and stair tread replacement in 2025. At that time the wood bridge decking leading to Building 1410 should be replaced as needed.

Description:
View of underside
of typical wood
landing in
breezeway

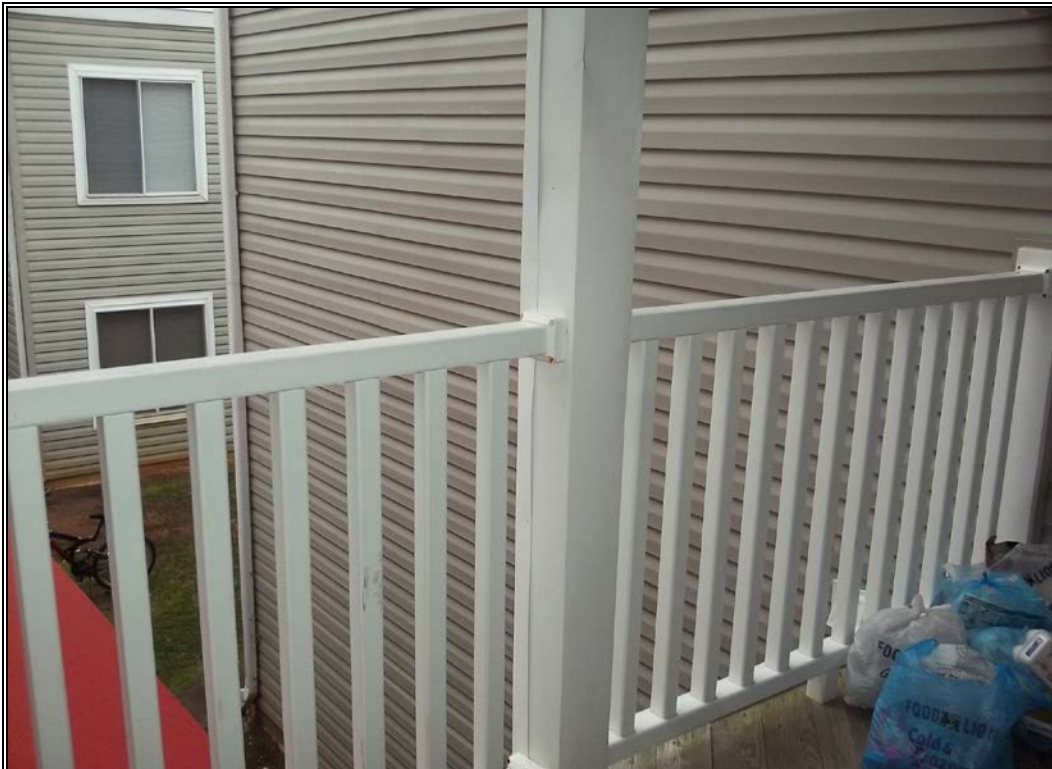
Photo Number
10

The PVC/vinyl railings at the breezeways and unit balconies appeared to be in adequate condition. We anticipate that many of the railings will require replacement

Description:
PVC railing
system at
breezeway landing

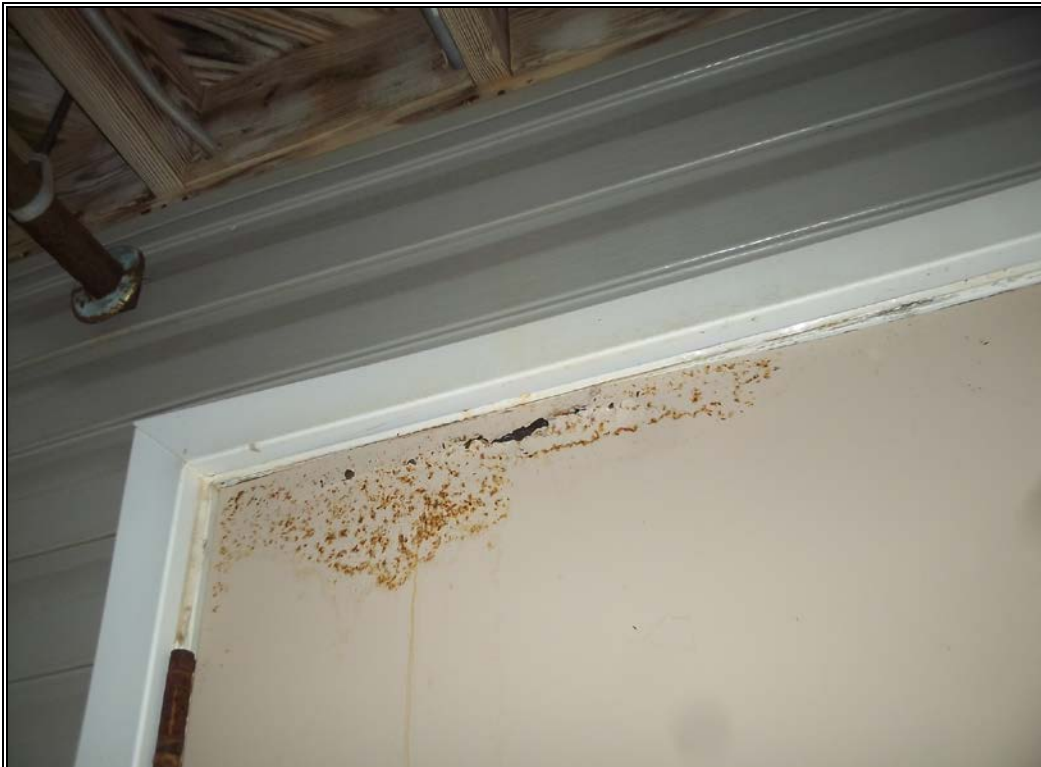
Photo Number
12

Description:
View of rusted metal storage room door

The front entrance doors leading to each unit, the storage rooms, fire sprinkler system rooms and pool building should be painted on an approximately 7-year cycle. We have allocated funds to paint all of the metal doors on a seven year cycle beginning in 2017. Note that the storage room and pool doors that lead to non-conditioned spaces are more subject to rust and deterioration (we observed rust on some of these doors). We have allocated funds to replace these ten metal doors on a 15-year cycle beginning in 2020. Repairs and replacement of condominium entry doors are the responsibility of the individual condominium owner and no funds allocated for repairs to these doors.

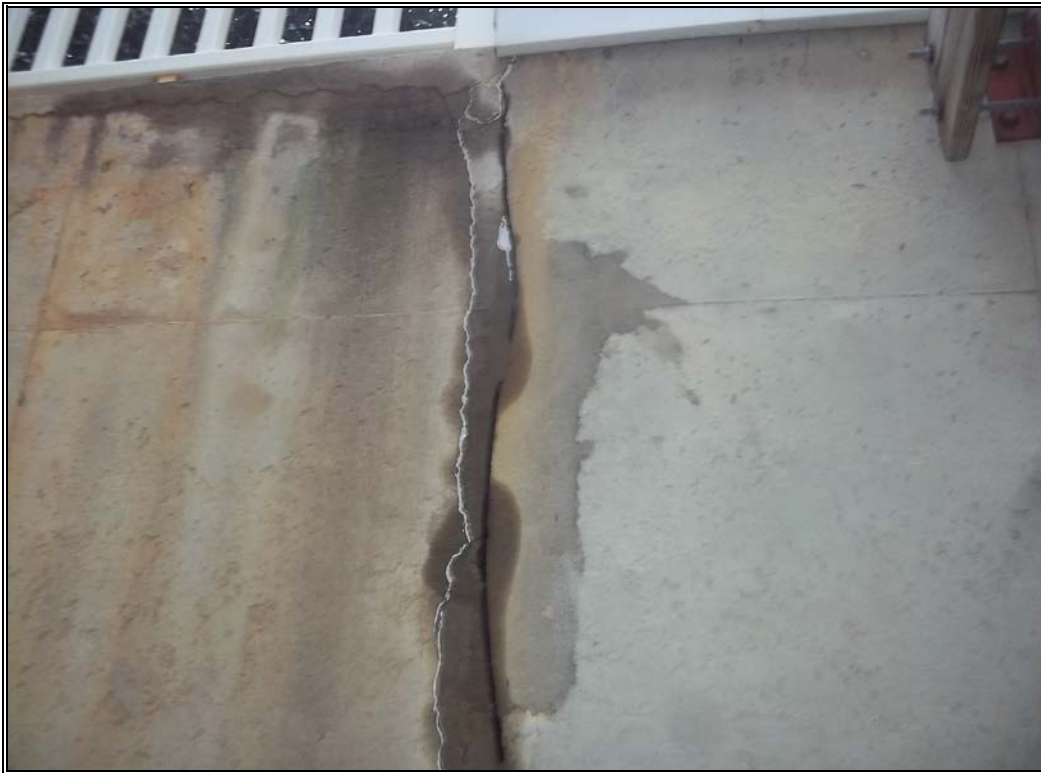
17

The segmental concrete retaining walls generally appeared to be in fair-to-good condition. We noted significant cracking of the poured concrete walls between Building Nos. 1241-1251, between Building Nos. 1221-1231 and between Building Nos. 1341-1351. These vertical cracks (up to ½-inch wide) have been resealed in the past and the cracks have widened with limited horizontal displacement noted in the walls. These walls should be monitored for further movement and we have allocated funds to stabilize these wall sections (using helical tie-backs or wall anchors with

View of relatively wide crack in poured concrete retaining wall – typical of several buildings

rods) in 2022. At the time of repair, the drainage system behind these sections of wall should be improved to minimize further hydrostatic pressure on the wall.

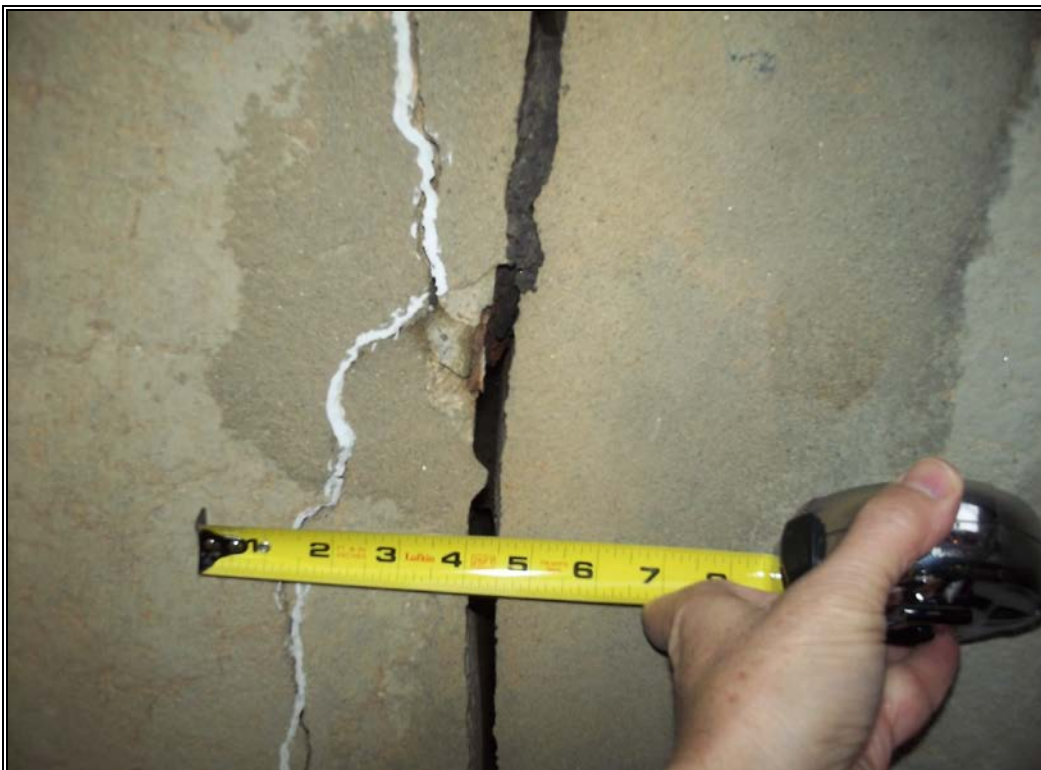
View of nearly 1/2-inch wide cracked poured concrete wall section

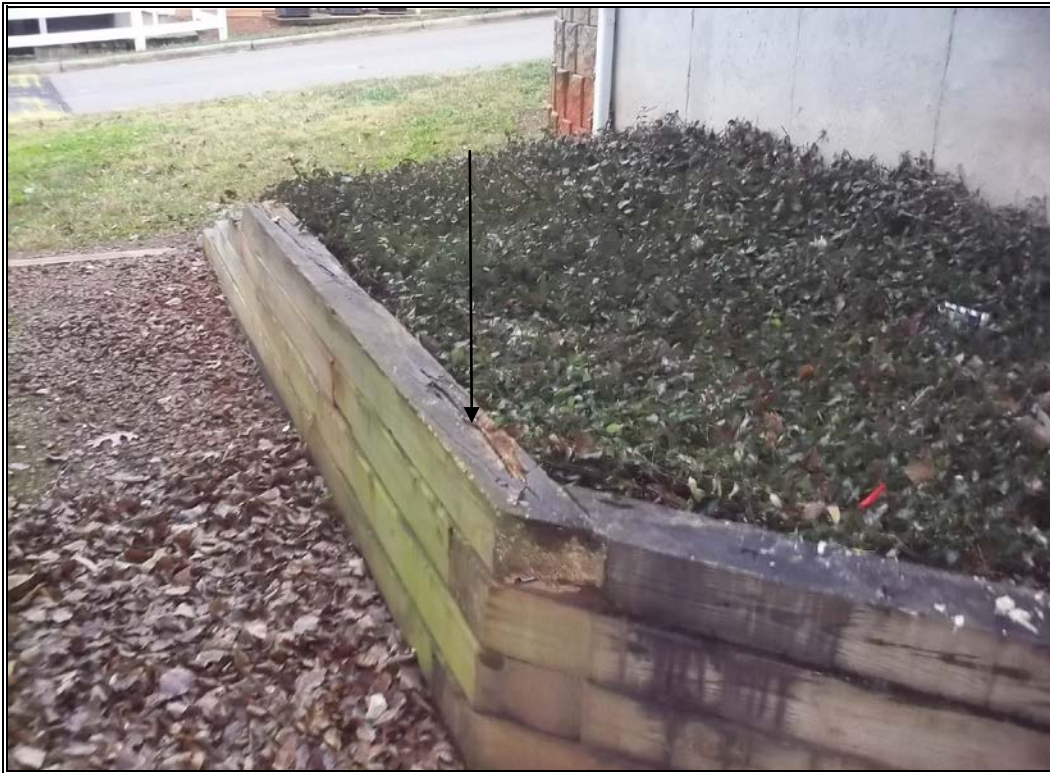
Photo Number
19

The vertically short sections of wood retaining walls and planters have an expected life of approximately 20-24 years. We observed limited deterioration to some of the wood members. We have allocated funds to replace all the wooden retaining wall/planter sections in 2020.

Description:
View of typical short section of wood retaining wall – note deterioration in top of wall

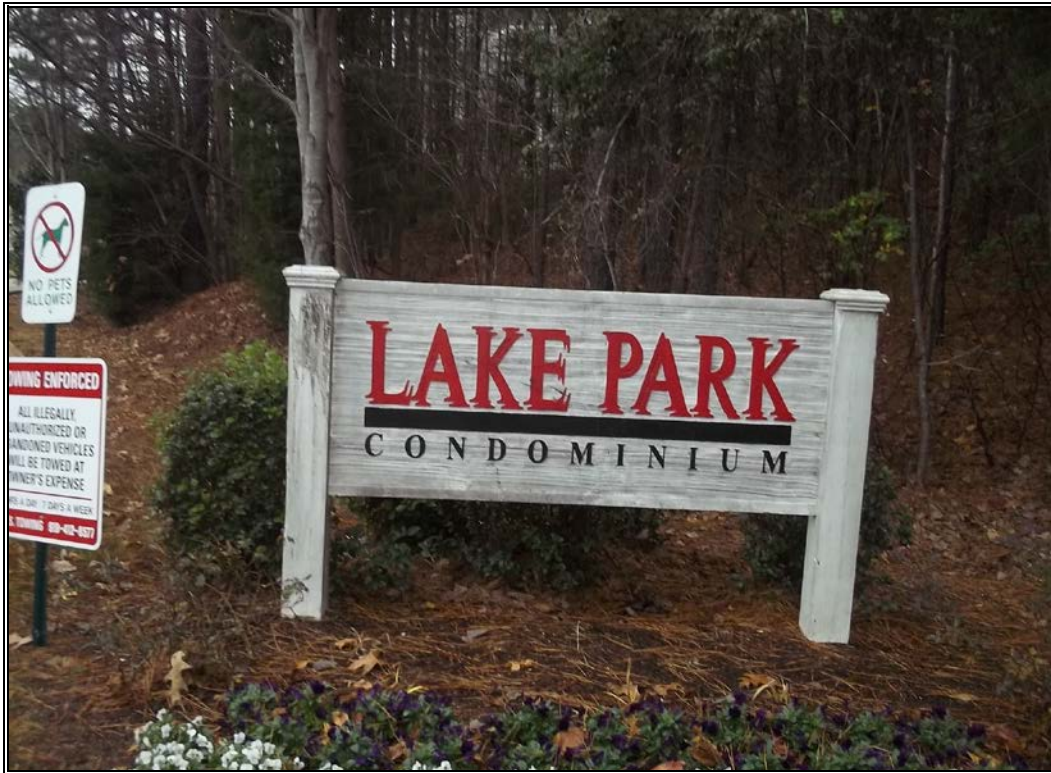
Photo Number
21

The entrance signage on Lake Dam and Crab Orchard appeared to be in adequate condition but the paint exhibits some signs of fading. The painted signage will likely to continue to fade and exhibit discoloration in time. Any required painting of the signs should be funded from the Maintenance budget. We have allocated funds to replace and upgrade the two entrance signs with new sign systems in 2020.

Description:
View of one of
two entrance signs
mounted on
pressure treated
posts

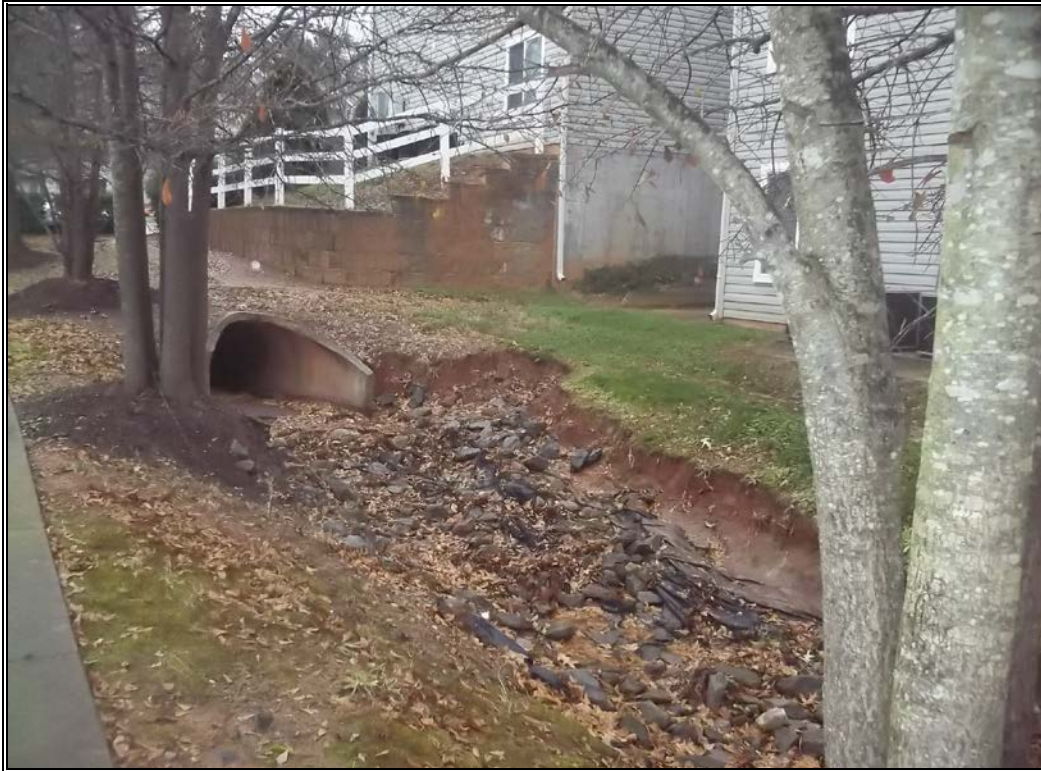
Photo Number
23

The piped drainage systems in the community generally appeared to be in fair-to-good condition. However, we noted significant erosion of the swale between Lake Dam Road and Building No. 1251. The erosion is in relatively close proximity to the foundation of this building. We have allocated funds to repair this swale (install additional rock or rip-rap) in 2015. We also noted limited erosion at other areas of the property including at the fencing above the retaining wall between Building Nos. 1331 and 1341.

Description:
View of erosion in
drainage ditch
adjacent to
Building 1351

We have allocated funds on an 8-year cycle for additional drainage repairs/improvements. Future repairs will likely include retrenching of swales to improve flow, installing additional rip-rap, repairing catch basins and underground piping and/or installing French drain or other types of drainage systems.

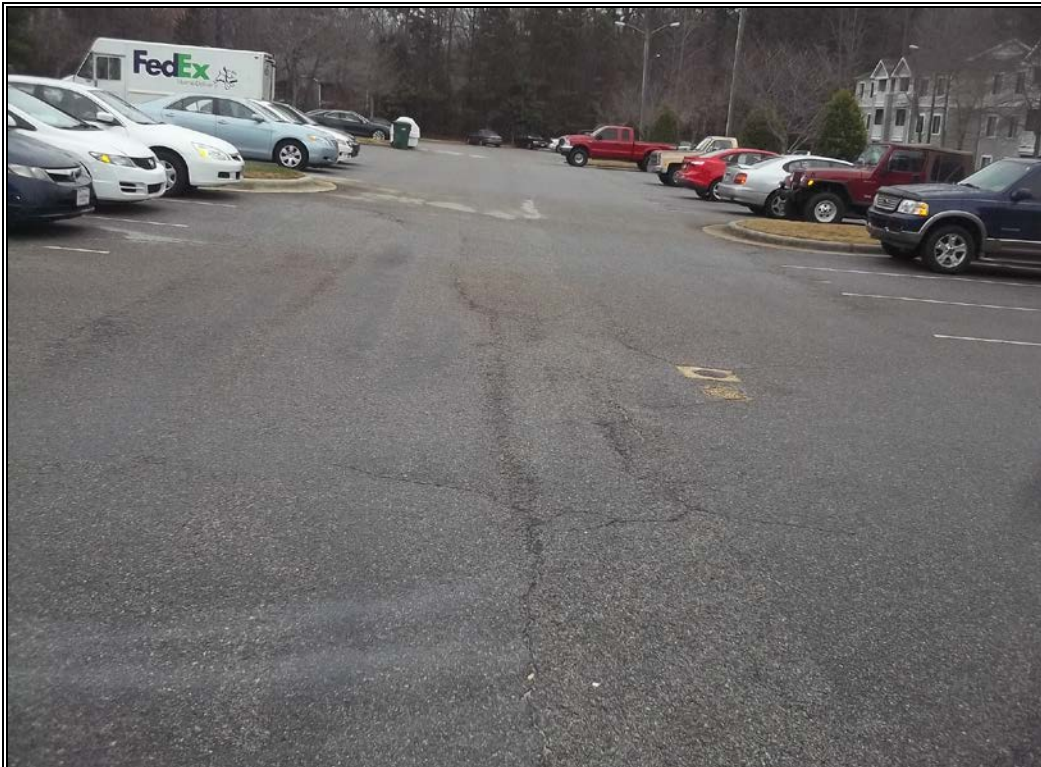
Photo Number
24

The asphalt paving appears to generally be in fair-to-good condition.

Description:
Typical condition
of asphalt parking
lot and driveway

Typically, we recommend the application of an oil resistant sealant to all asphalt paved surfaces on a seven-year cycle. At this same time, all cracks should be properly filled, patched, and sealed. We have allocated funds to seal and repair cracks on a seven-year cycle beginning in 2015. We have also allocated funds for full-depth repairs of existing potholes and alligatored areas of paving in 2015 and anticipate that similar full-depth repairs will be required on a 10-year cycle.

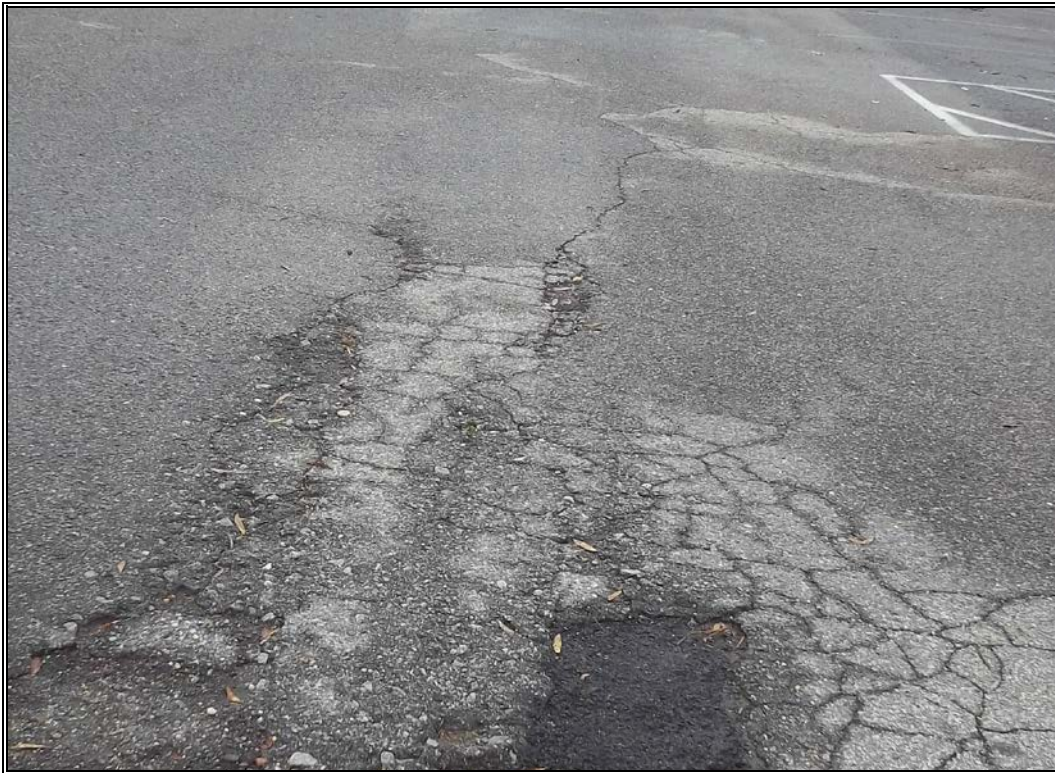
Photo Number
25

Except for isolated areas (notably behind Building 1220), no significant upheaval, depressions or potholes were observed in the existing pavement. However, we did observe relatively wide cracks in limited areas of the parking lots and streets and the asphalt paving did not appear to have been recently resealed. The striping was worn in many areas.

Description:
View of pothole
and alligator
cracking in
driveway behind
Building 1220

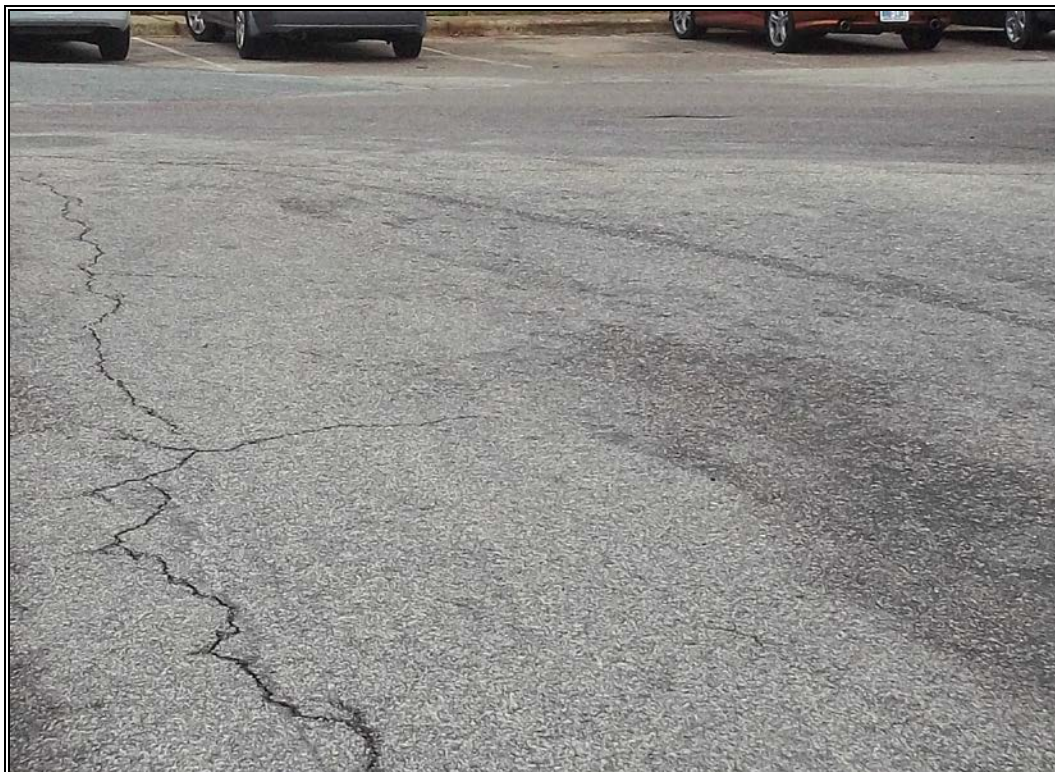
Photo Number
26

Description:
View of typical
cracking in
driveway

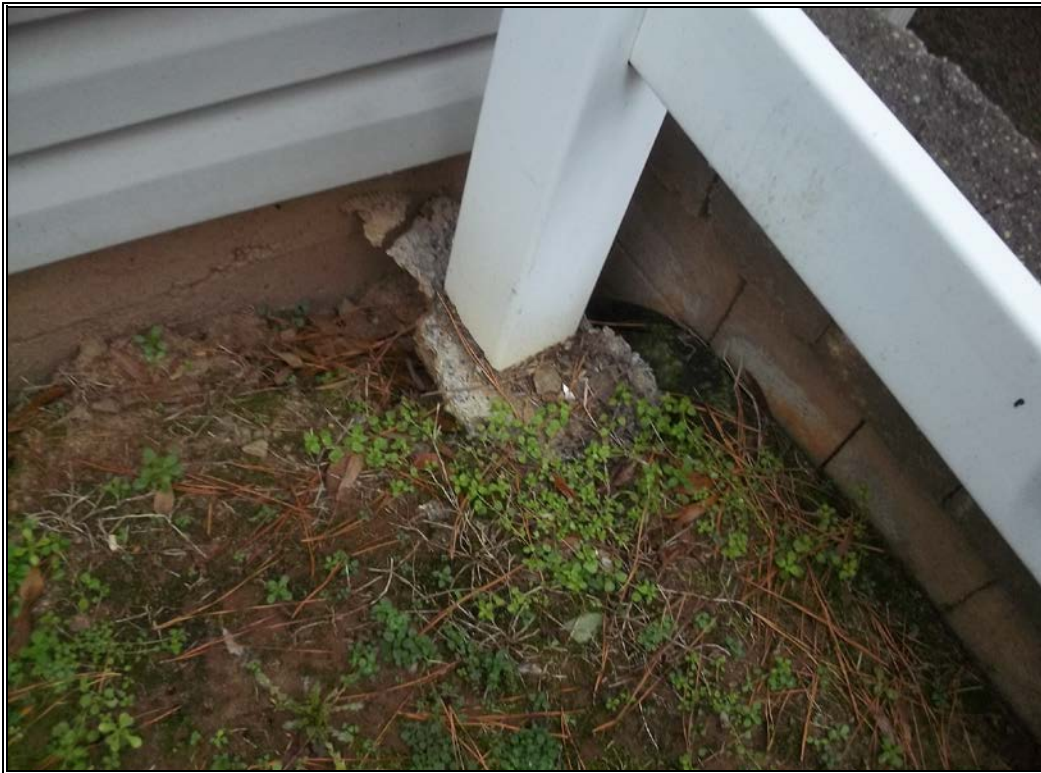
Photo Number
27

Description:
View of erosion at
Building 1331 end
wall – PVC post
footing is
undermined

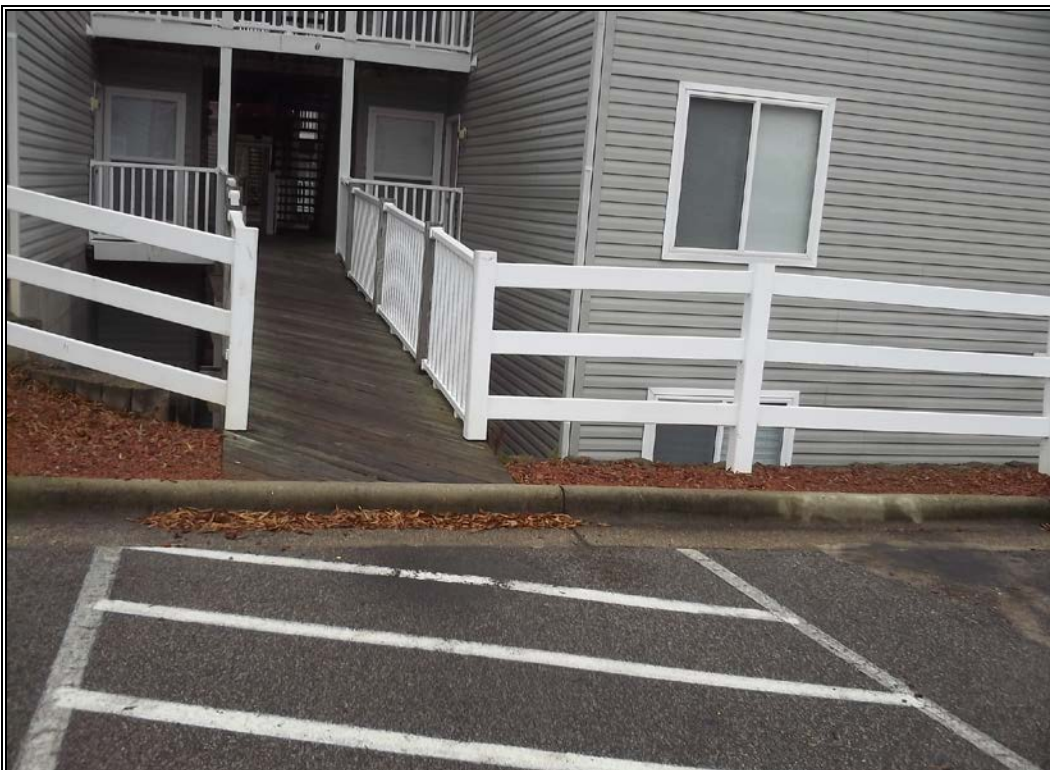
Photo Number
28

Description:
View of bridge
leading to Building
1410 next to office

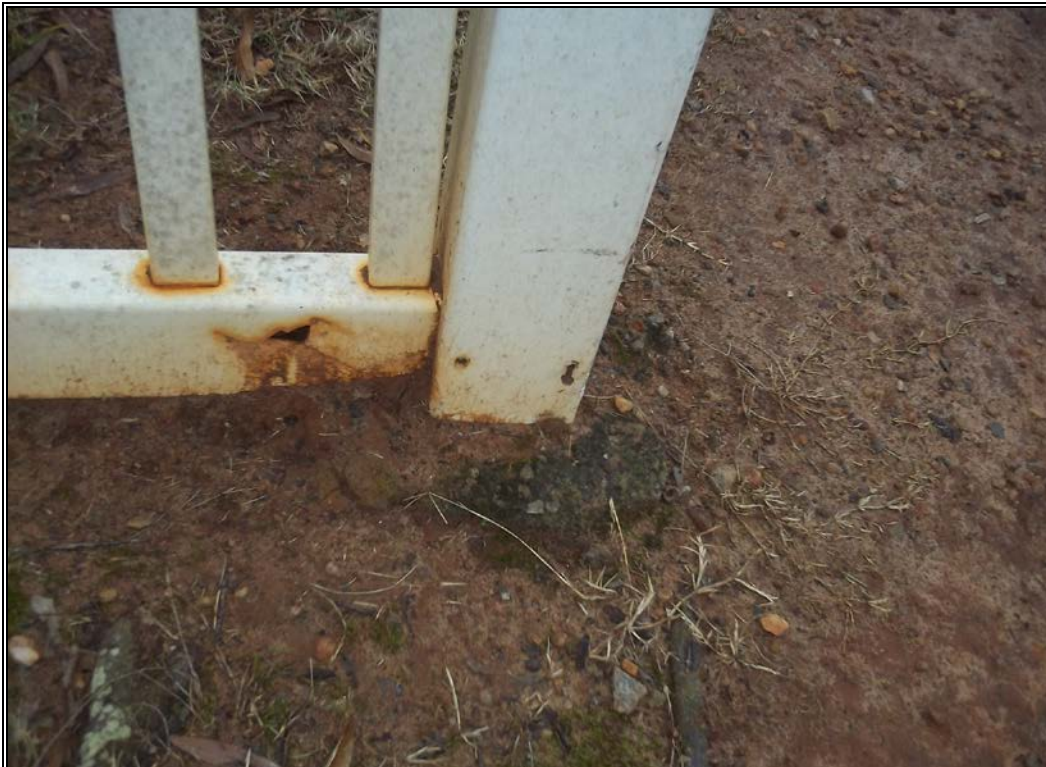
Photo Number
30

The PVC/vinyl fencing appeared to be generally in fair-to-good condition. We observed limited deterioration in sections of fencing and over time all the fencing will begin to deteriorate and/or fade in color. We have allocated funds to replace the fencing on a 25-year cycle beginning in 2023.

Description:
View of
deterioration at
bottom rail of PVC
fencing

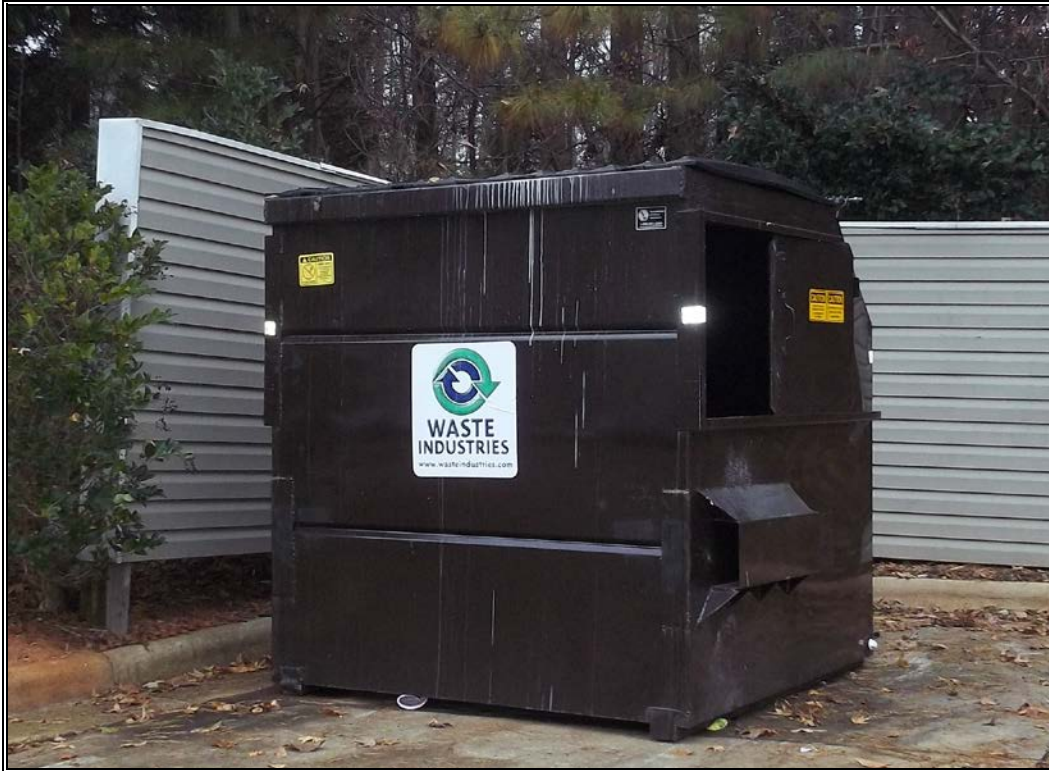
Photo Number
31

The vinyl/PVC fencing used to screen the waste dumpsters is showing signs of deterioration. The life of this fencing is approximately 20 years and we have allocated funds to replace all these screening systems in 2020.

Description:
View of typical
waste dumpster
with vinyl fence
screening

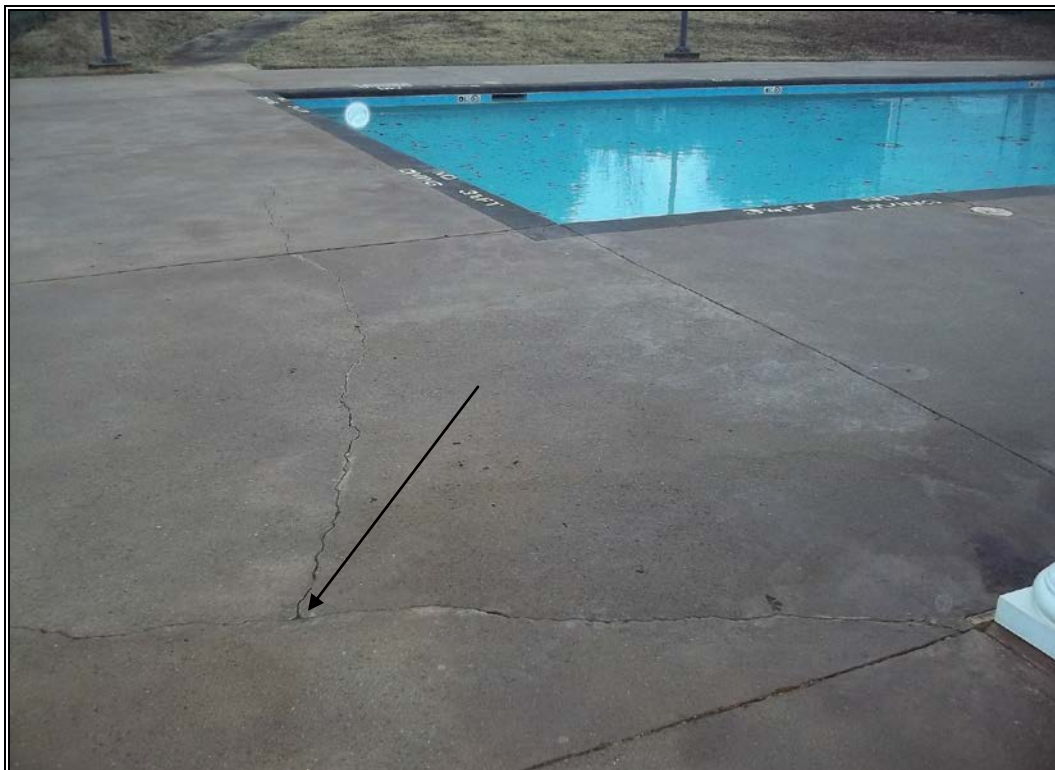
Photo Number
34

Description:
Typical cracking
in concrete deck
around pool

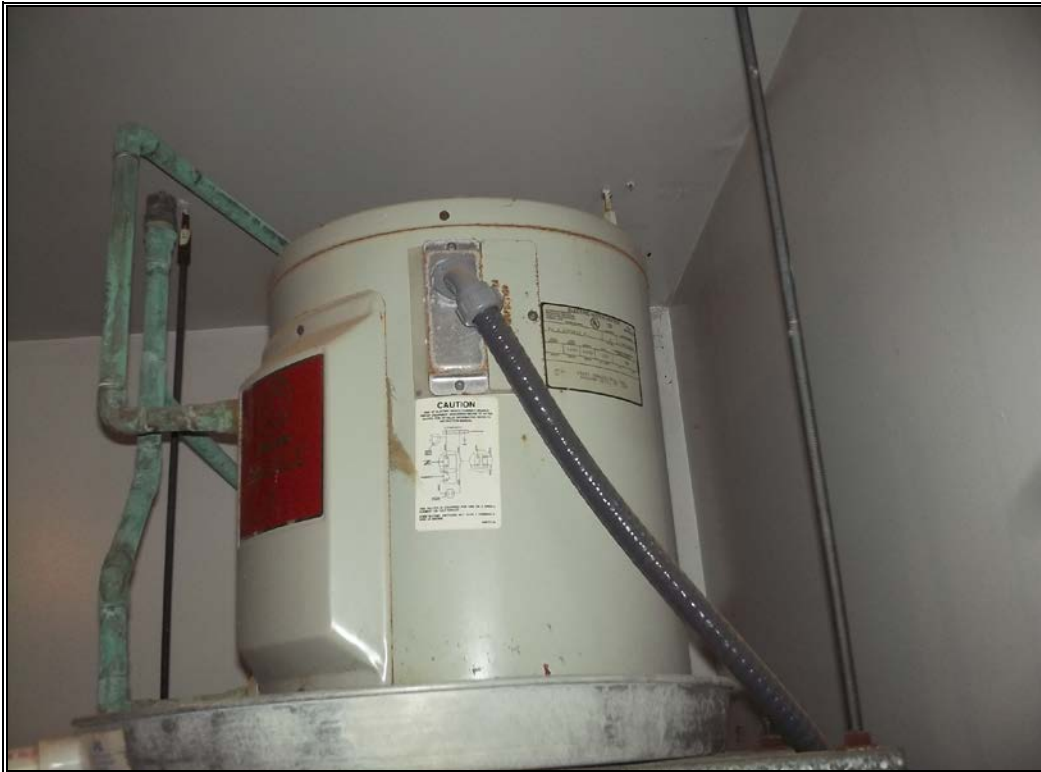
37

The small water heater has operated beyond its expected life and will likely require replacement in the near term. We have allocated funds to replace on a 15-year cycle beginning in 2015.

Small water heater
in pool equipment
room

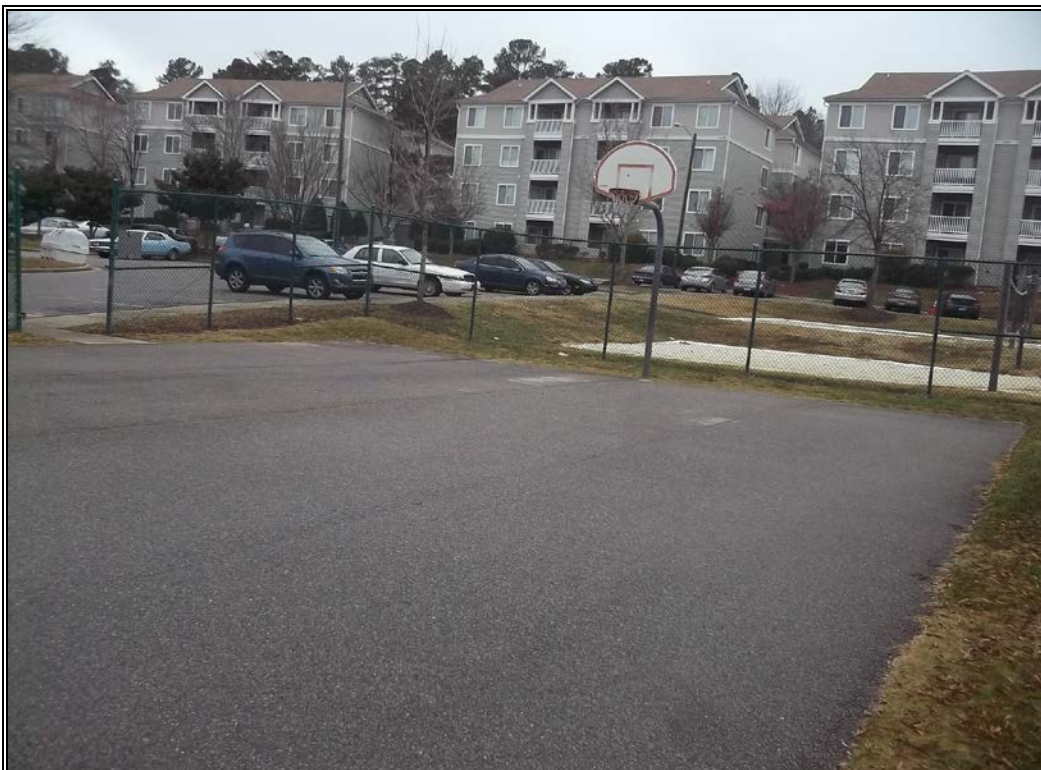
We observed minor damage to the fencing surrounding the basketball court (fence top rail not connected). The fencing around the pool appeared to be in good condition and we do not anticipate complete replacement of either the basketball court or pool area fencing will be required during the 20-term of this study. Minor repairs to the fencing (and replacement of the 3 gates if required) should be funded from the Maintenance budget.

View of basketball
court and
volleyball courts in
background

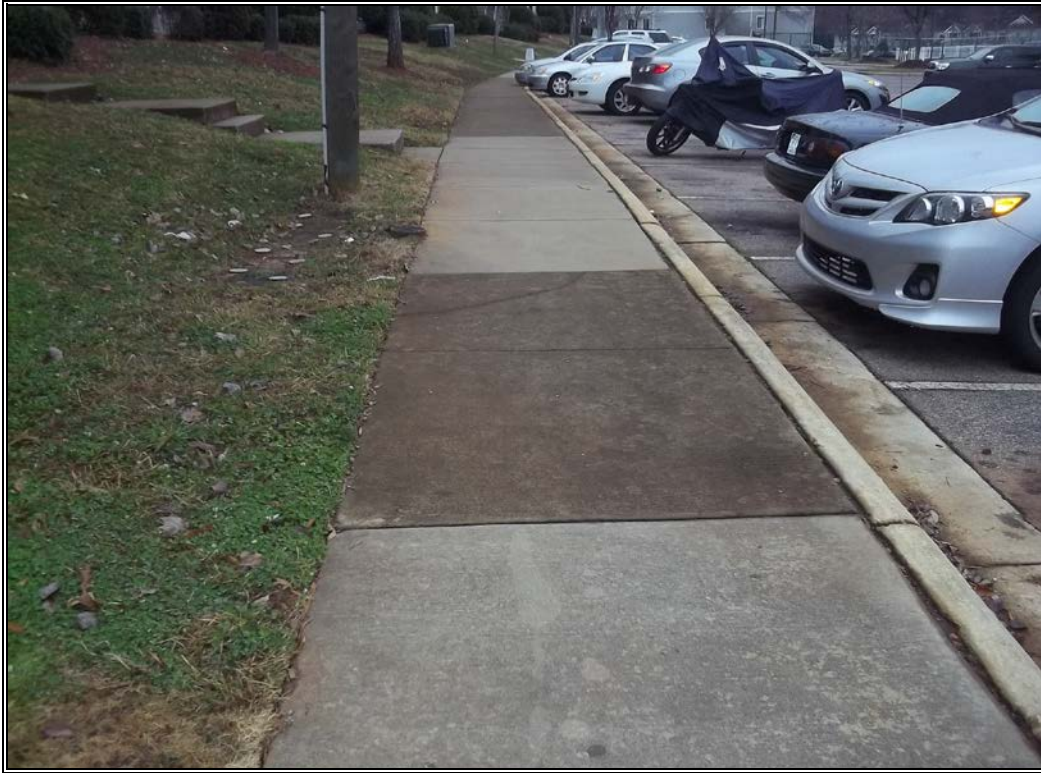
Photo Number
41

The concrete curb and gutter generally appeared to be in good condition; however, we did observe limited damage in some curbing. It is likely that due to differential settlement and vehicular damage, sections of the concrete curb and gutter will require repair on an approximately 8-year cycle. We have allocated funds to repair approximately 5% of the total amount of concrete curbing every 8 years, beginning in 2018.

Description:
Note concrete sidewalk, curb and gutter
