RESERVE FUND STUDY UPDATE

AVERA PLACE CONDOMINIUM ASSOCIATION

Raleigh, North Carolina

August 30, 2017

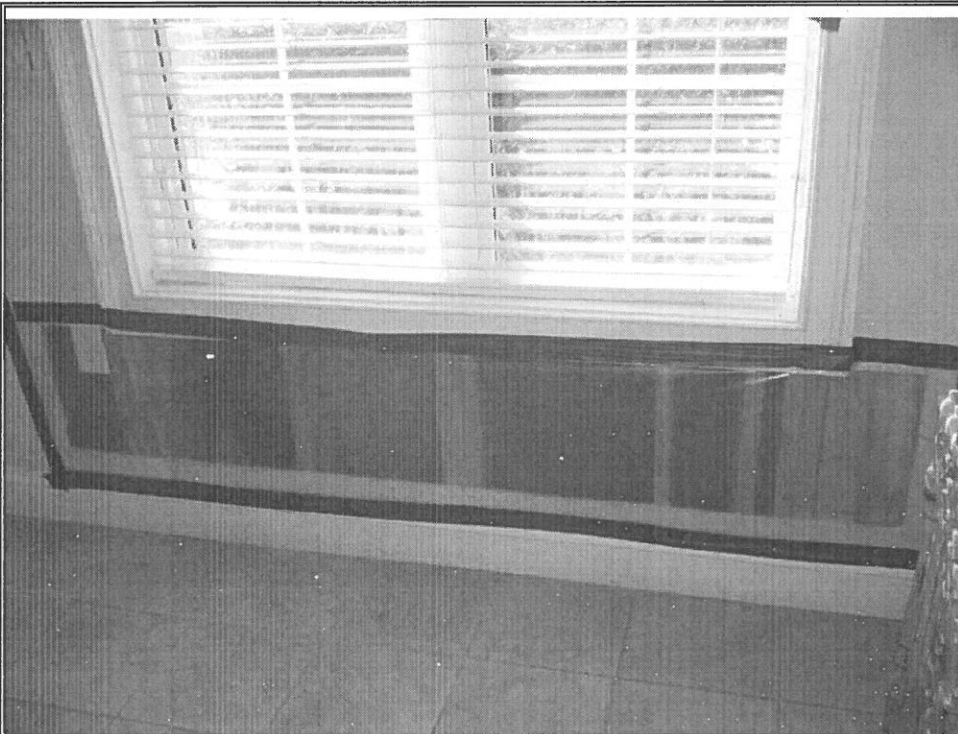
Photo Number
4

Description:
Previous water
intrusion required
repairs to
clubhouse wall

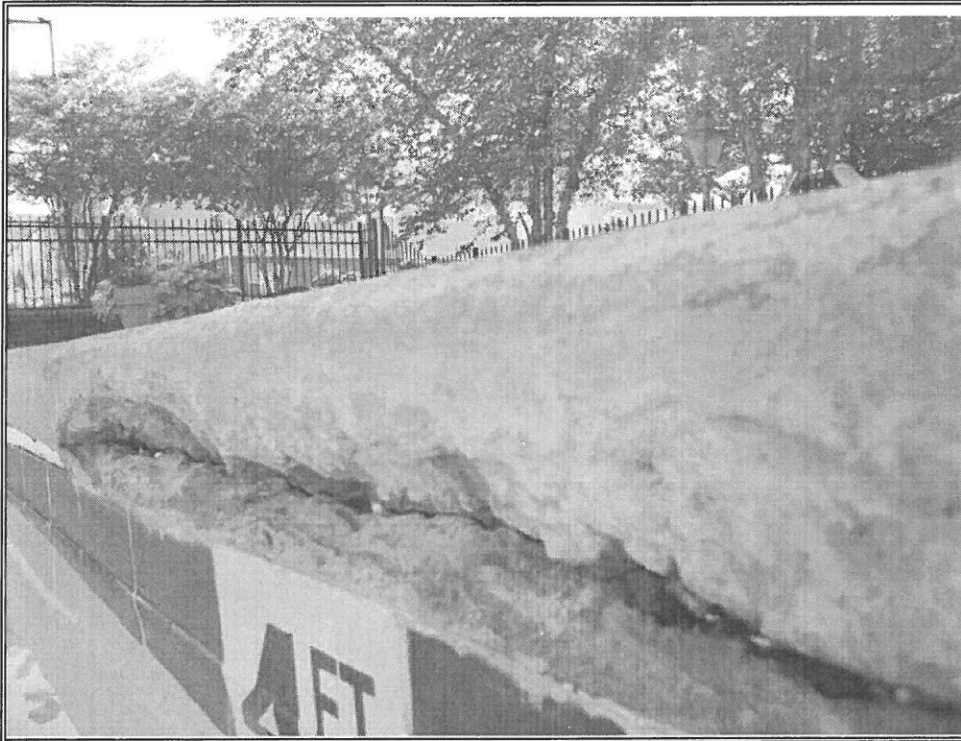
Photo Number
7

Description:
Note damage to
pool coping

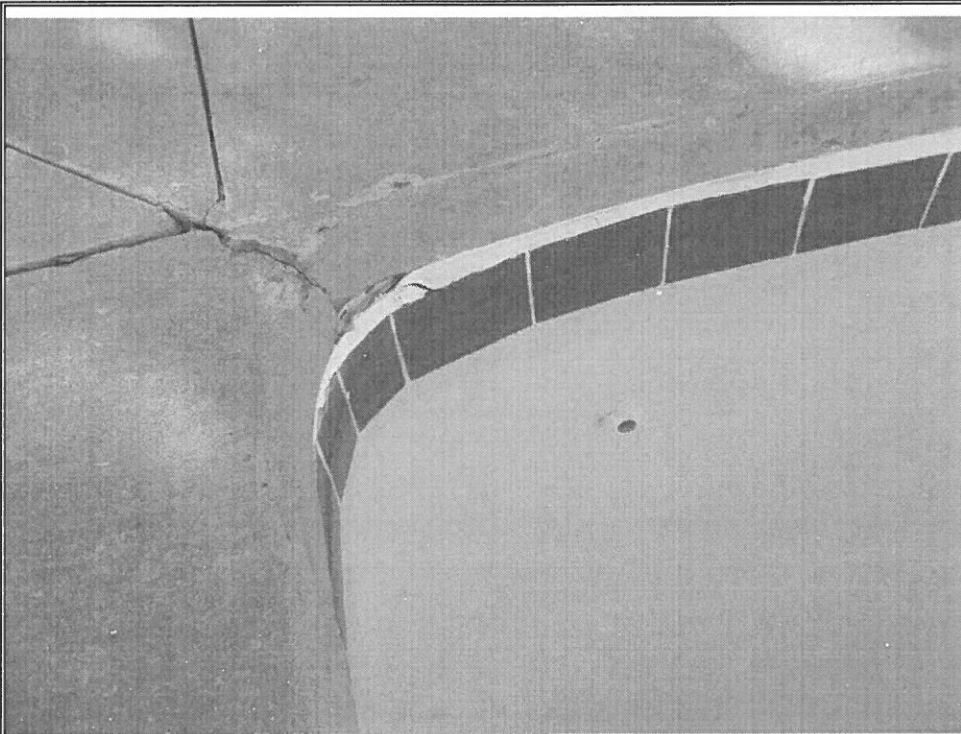
Photo Number
8

Description:
Damage to pool
coping and
waterline tiles

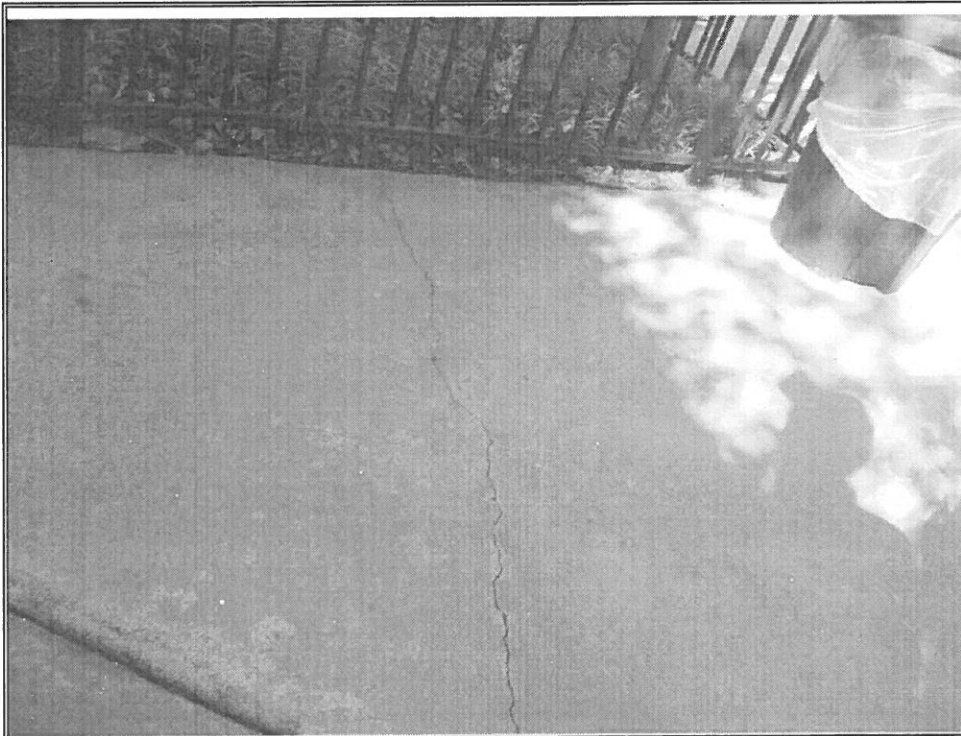
Photo Number
10

Description:
Typical crack in
pool deck

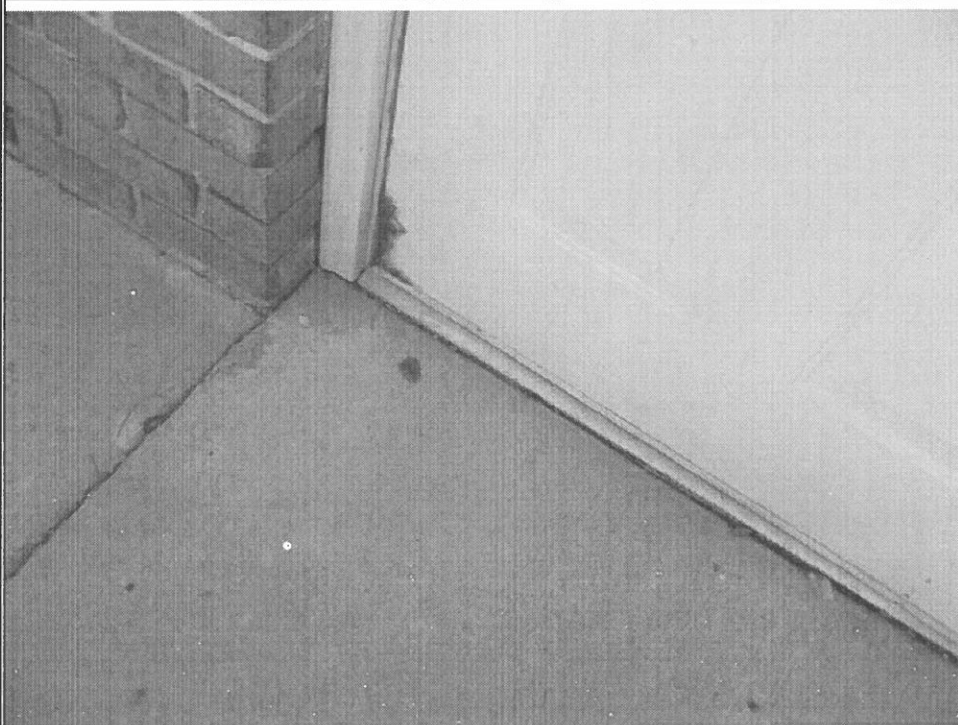
Photo Number
14

Description:
Rust at base of
pool room door

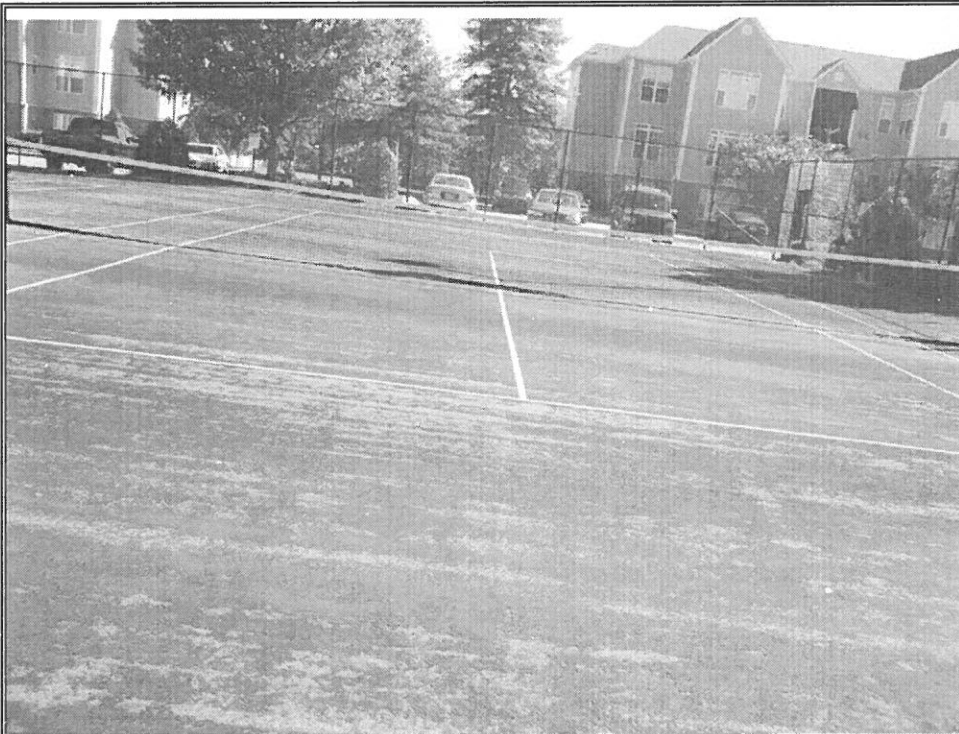
Photo Number
16

Description:
View of tennis
court surface wear

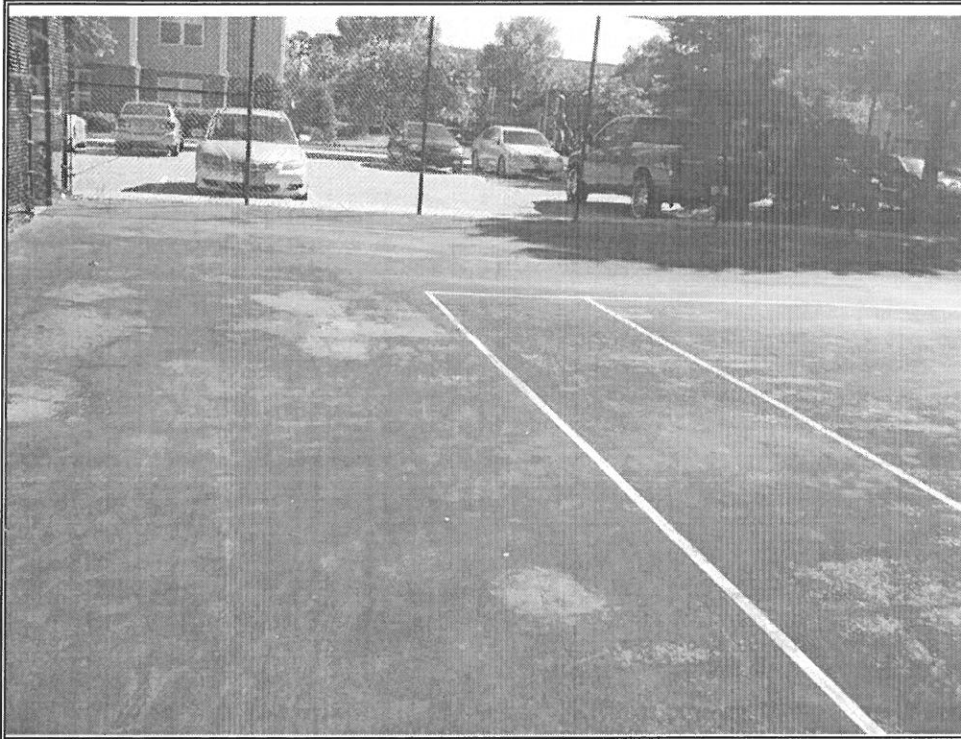
Photo Number
17

Description:
Another view of
tennis court
condition

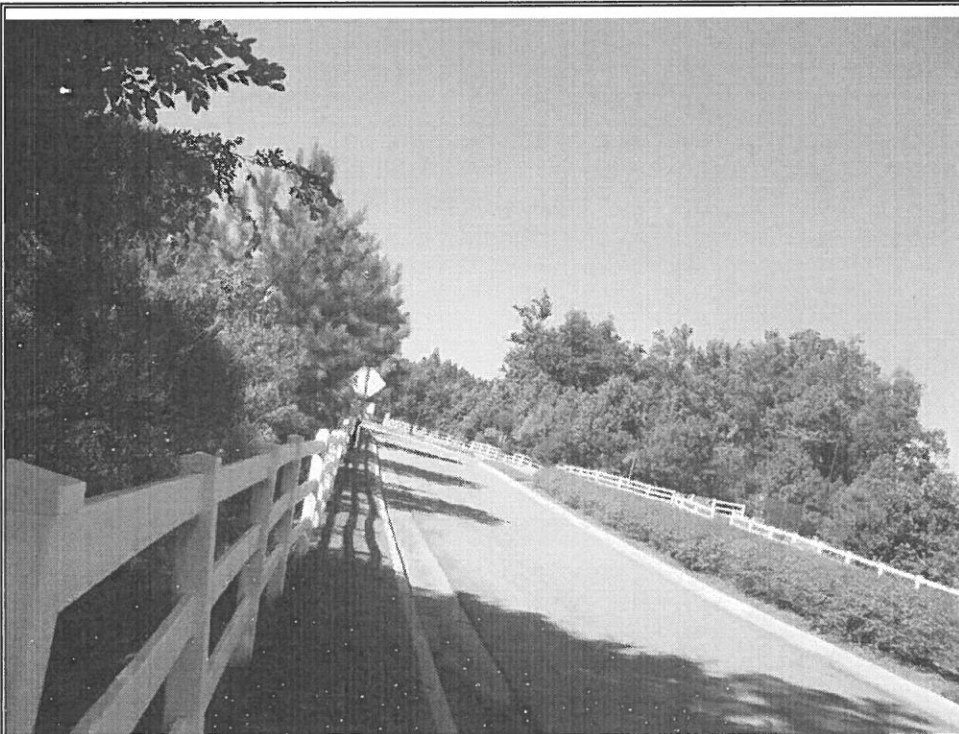
Photo Number
22

We have included funds for anticipated replacement of the PVC site fencing. Over the 20-year term of this analysis, portions of the fencing will be damaged by landscaping activities and wear from the elements. Additionally, we noted that significant portions of the site fencing along the entrance road leading to the community are leaning. We have allocated funds to replace the site PVC fencing in 2021.

Description:
PVC split rail
fencing is leaning
in sections

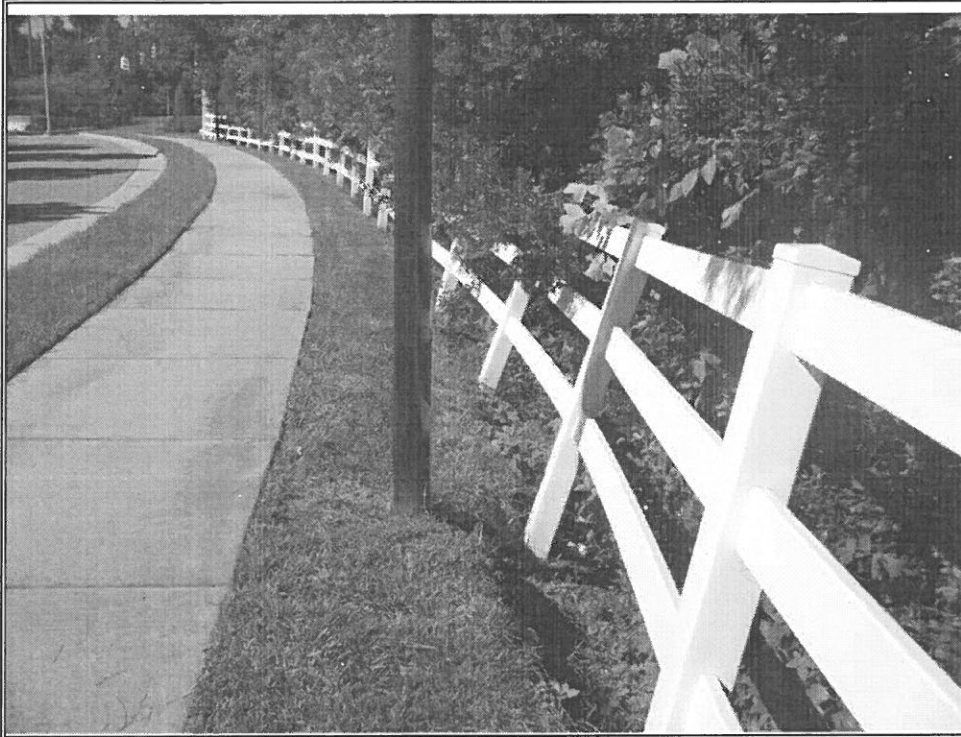
Photo Number
23

Description:
Another view of
leaning PVC
fencing

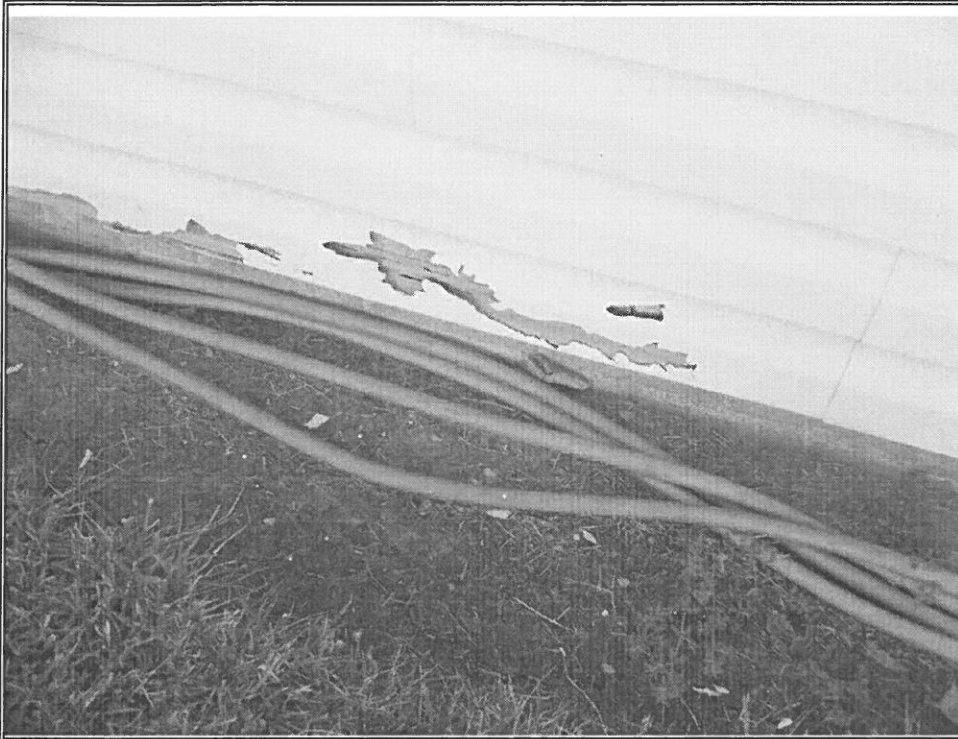
Photo Number
31

Note that siding and flashing repairs have been completed in recent years to minimize water intrusion. We observed during our inspection that the vinyl siding and trim has been damaged in several locations including base of siding at 100 Involute. This damage is apparently due to mowing and landscaping activities. We have made a provision in our budget recommendations for periodic (3-year cycle) repair of damaged siding and installation of new building wrap beginning in 2020.

Description:
Note damage to
vinyl siding at base
of wall

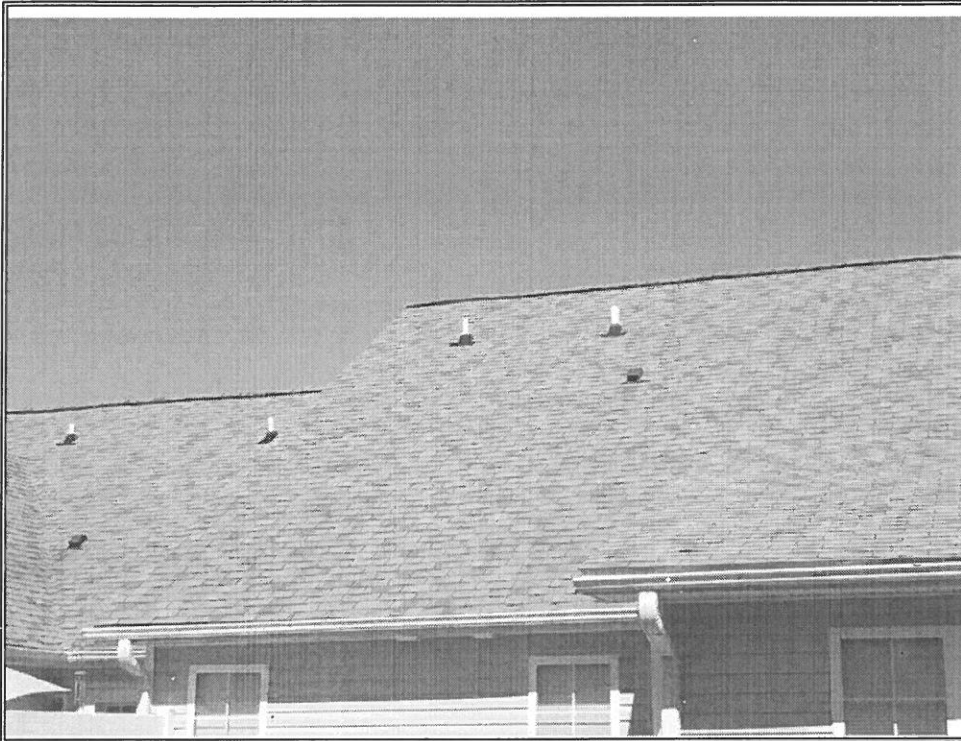
Photo Number
33

Typically, roofing surfaces are assumed to last approximately twenty years. It is our opinion that the expected useful life of the roof shingles in this community will be limited to an additional 5-10 years of service. Although the shingles likely have a 20-25 year warranty, growing evidence suggests that materials used on other similar construction projects, techniques used during installation of the surfaces, inadequate attic ventilation, and other substandard practices has played a part in shortening the expected useful life of the roof surfaces. We strongly recommend that any re-roofing project closely follow procedures outlined by the National Roofing Contractors Association's *Roofing and Waterproofing Manual*, Current Edition.

Description:
Another view or
typical roof
condition

We have assumed that 25% of the shingled roofing surfaces will be replaced on an annual basis beginning in 2022. A re-roofing sequence should include removal of the existing shingle surfacing, replacement of any inadequate roof sheathing, replacement of any damaged flashing, and replacement of drip edge components.

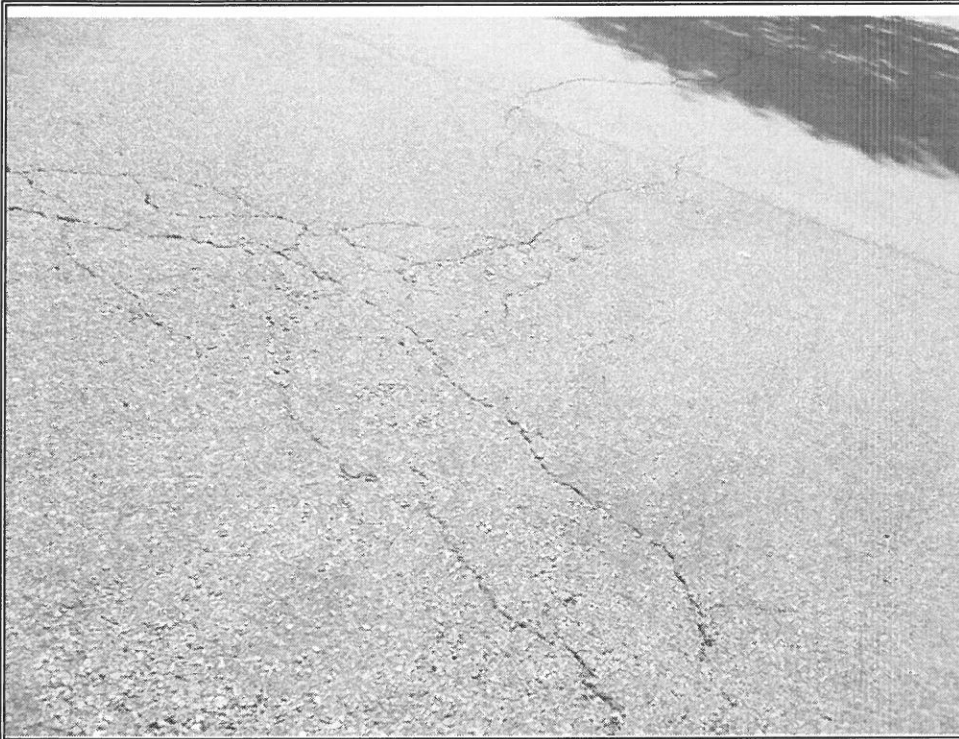
Photo Number
41

No indications of major structural failures were observed in the roads. However, we observed areas of significant cracking in the asphalt and some larger depressions and small potholes observed.

Description:
Note alligator
cracking in asphalt
street

Typically, we recommend the application of an oil resistant sealant or slurry to all asphalt paved surfaces on a five to eight-year cycle. At this same time, all cracks and potholes should be properly filled, patched, and sealed. Funds are allocated to complete road/parking lot repairs and reseal/stripe in 2018 and on a 7-year cycle.

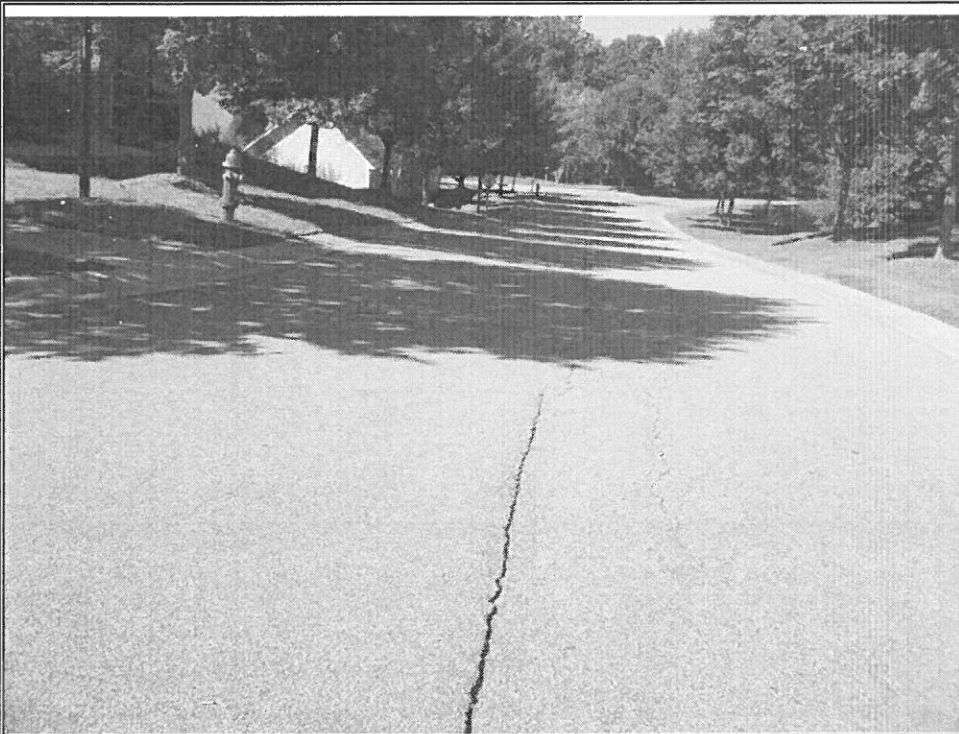
Photo Number
42

Description:
Longitudinal
cracking in asphalt
street

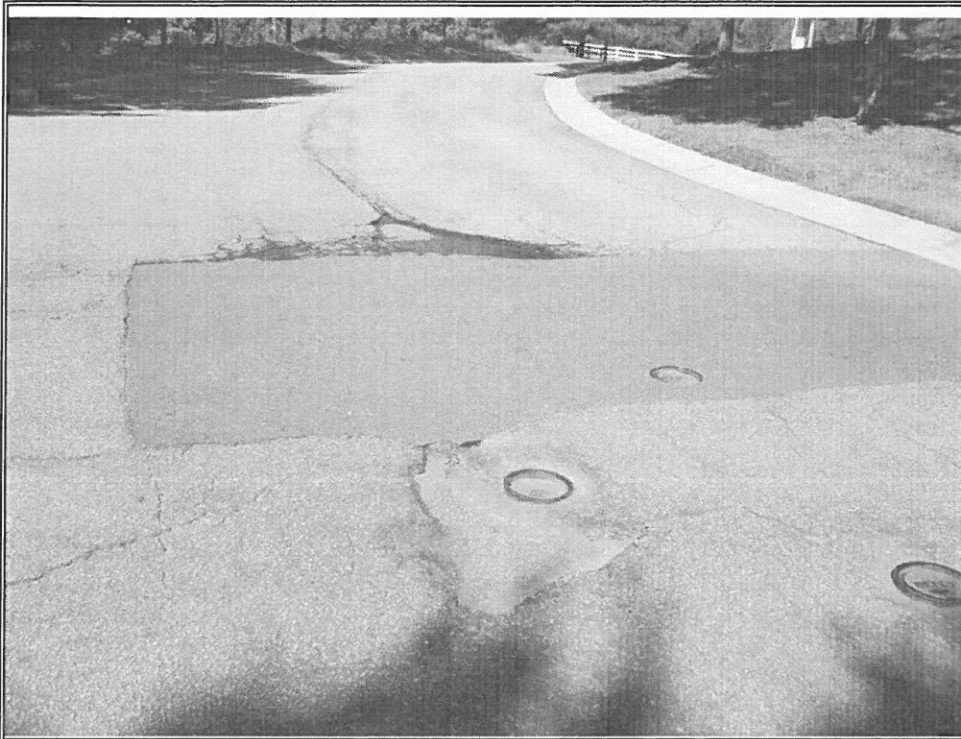
Photo Number
43

Description:
Note previous
repairs and damage
to asphalt street

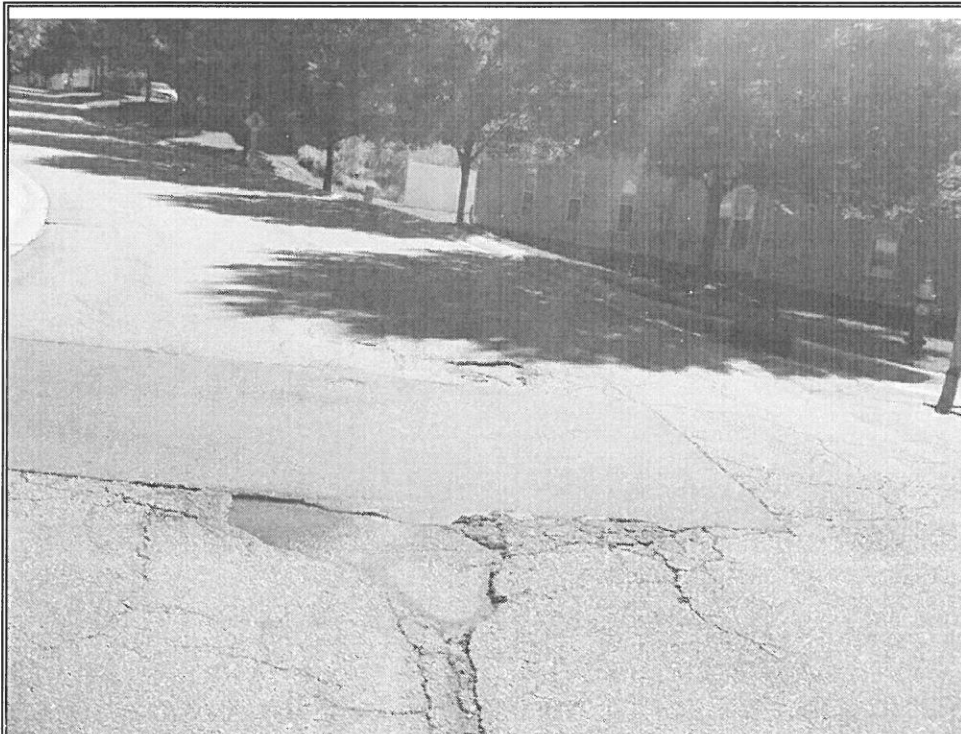
Photo Number
44

Description:
Another view of
damaged section of
asphalt

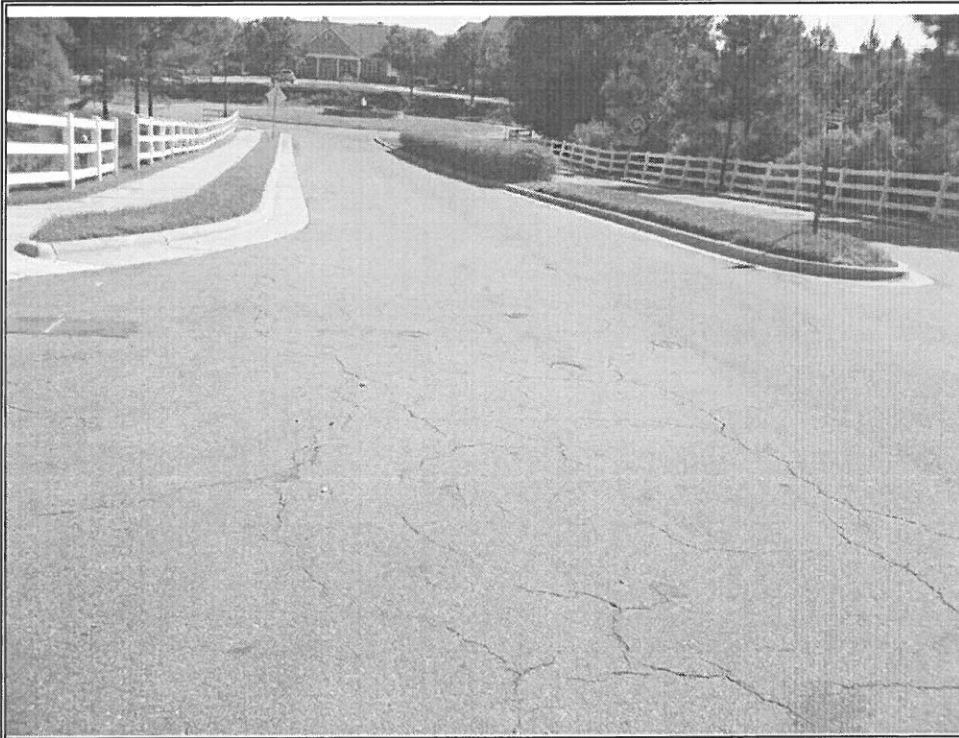
Photo Number
45

View of clubhouse
in background and
cracking in asphalt

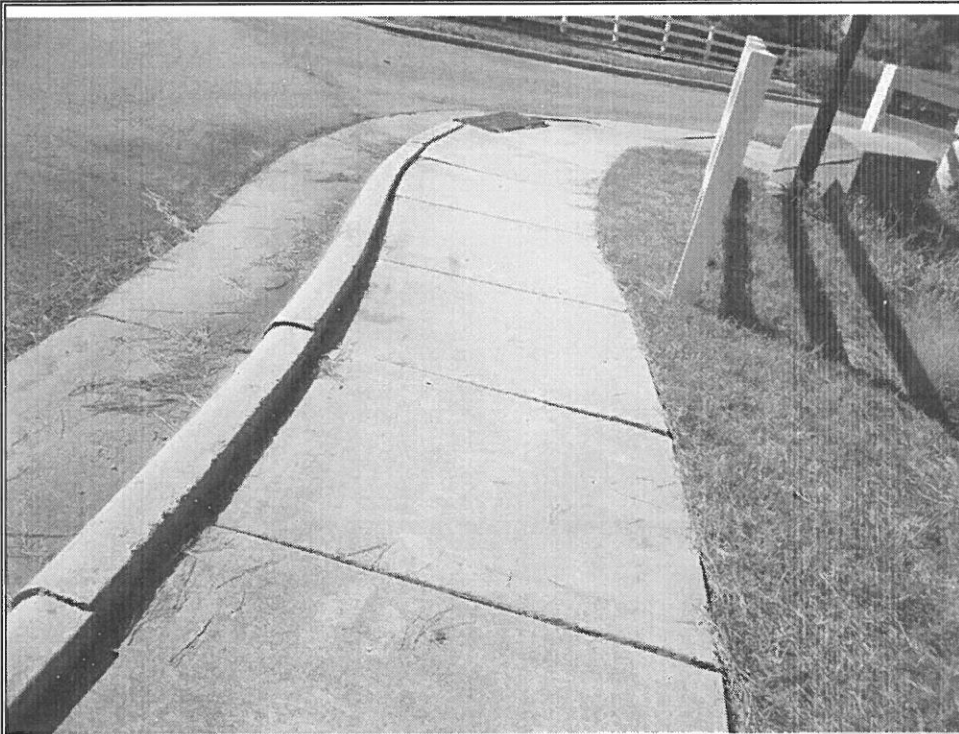
Areas of the concrete flatwork have settled and some cracking observed. Sections of sidewalk along the entrance road have settled below the top of curbing. The concrete flatwork will require periodic repairs due to increased settlement, upheaval and damage and we have allocated repair/replacement of 2% of all the concrete sections on 5-year cycle beginning in 2018.

Concrete
sidewalks sections
have settled
adjacent to curbing
near entrance
