FULL RESERVE STUDY

**AVERY CLOSE
RALEIGH, NC**

Prepared for:
**AVERY CLOSE CONDOMINIUM
RALEIGH, NC
&
WILSON PROPERTY MANAGEMENT**

MAY 2, 2016

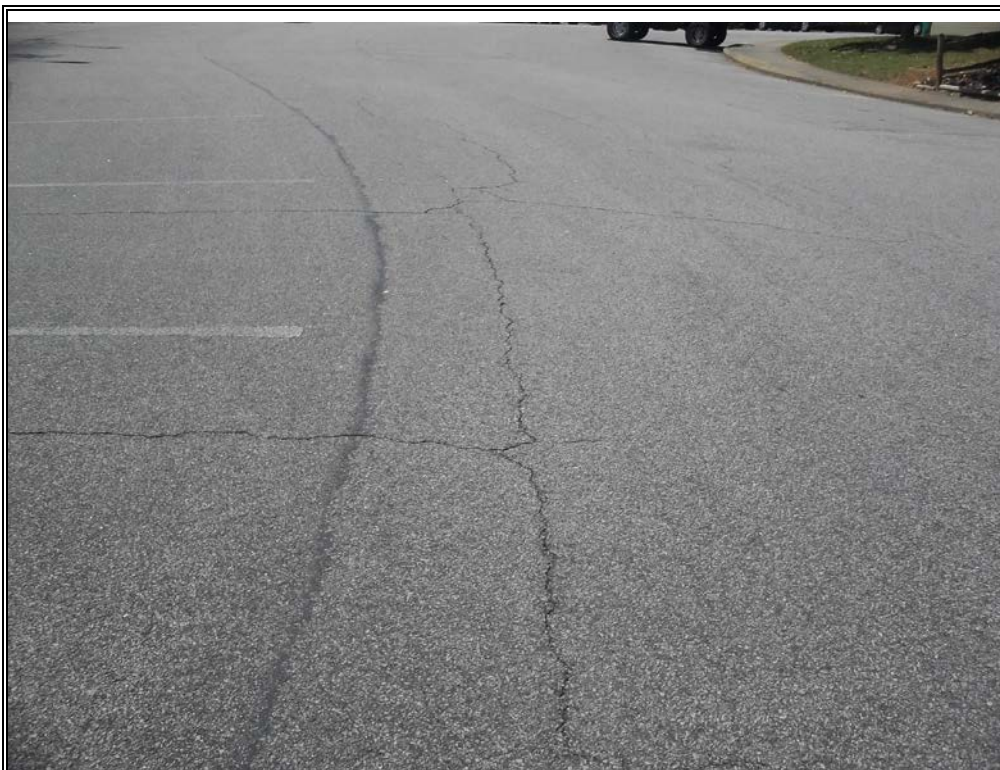
Photo Number
2

The parking areas and streets throughout the community are asphalt paved and are privately maintained by the Association. The asphalt paving generally appeared to be in good to fair condition and appears to have been resurfaced at some point since original construction. We noted areas of sediment accumulation around curb inlet basins near the entry areas of the parking lot. We also noted longitudinal cracking developing throughout the asphalt paved areas. The areas of sediment accumulation appear to be the result of an inadequate drainage profile preventing stormwater from draining into the inlet basins. These areas will likely require full depth repair to provide an adequate drainage profile. This would include saw cutting and removing sections of paving, repairing base course/sub-grade as needed and installing new 2" to 4" thick asphalt paving. We have allocated funds for full depth repairs of sections of the paving on a 7 year cycle beginning in 2018.

Description:
View of
longitudinal
cracking
developing in
asphalt paving.

Typically, we recommend the application of an oil resistant sealant to all asphalt paved surfaces on an approximately 5 year cycle. At this same time, all cracks should be properly filled, patched, and sealed. We have allocated funds for crack repair, seal coating and re-striping the pavement beginning in 2018 and on a 7 year cycle.

Assuming repairs, crack filling and seal coating are completed in the interim, we estimate the asphalt paving to have a remaining useful life of approximately 15 years prior to resurfacing. Full resurfacing would include milling sections of existing paving and installing a new 1.5 – 2” layer of asphalt over all of the existing paving. Milling of areas and full depth repairs will likely be required at resurfacing to repair areas of significant cracking/depressions/upheaval and to maintain an adequate drainage profile. We have allocated funds for resurfacing the paving on a 25 year cycle beginning in 2032.

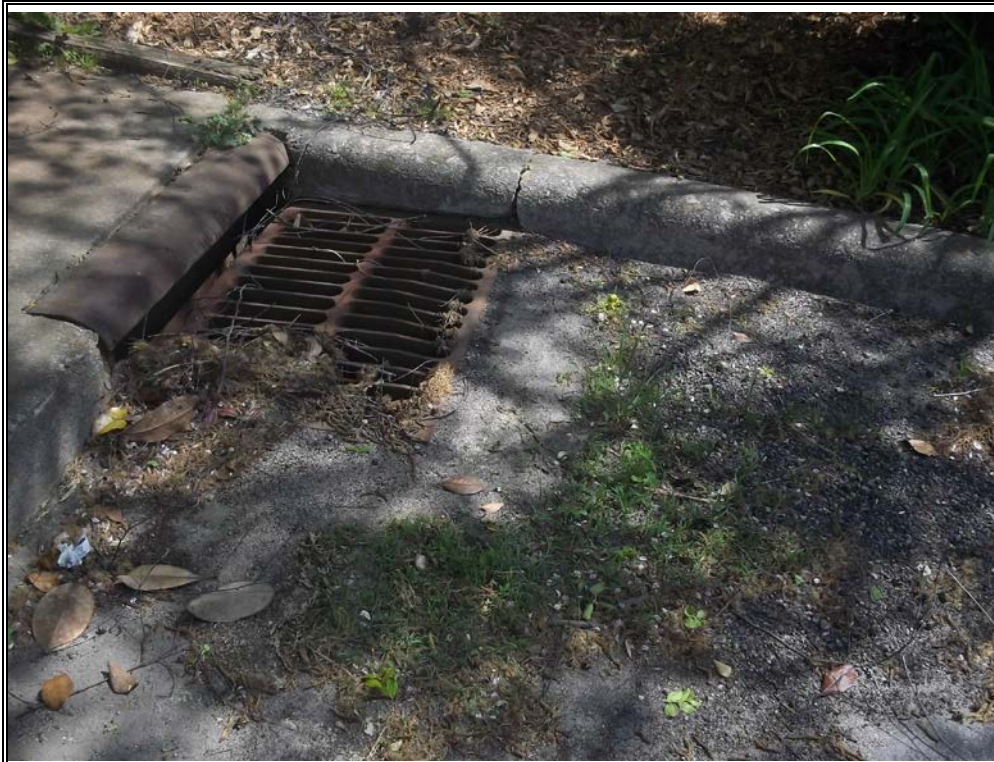
Photo Number
3

Limited sections of the streets and parking areas are lined with concrete curb and gutter. We noted limited sections of significant cracking and upheaval. As noted above, sediment accumulation was noted in paved areas around curb inlet basins near the front entry. We have allocated funds to repair sections of the concrete curb and gutter on a 10 year cycle beginning in 2017. This would include saw-cut and removal of damaged areas of curbing and installing new concrete curbing.

Description:
View of sediment
accumulation
around inlet basin
in curbing.

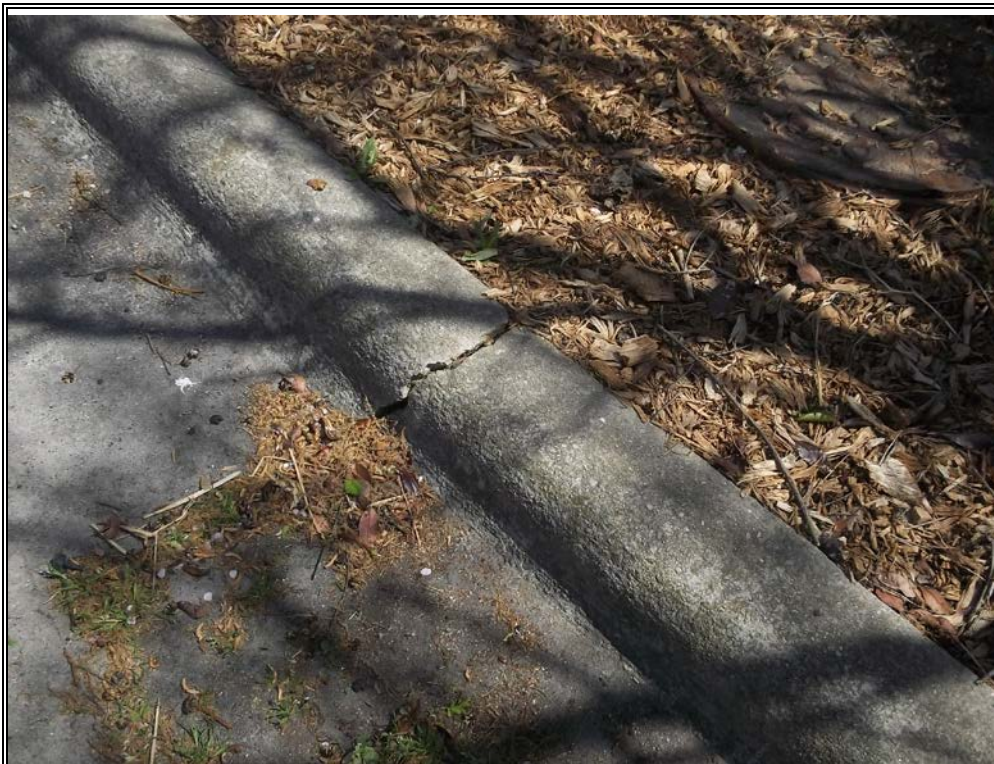
Photo Number
4

Description:
View of cracking
developing in
curbing.

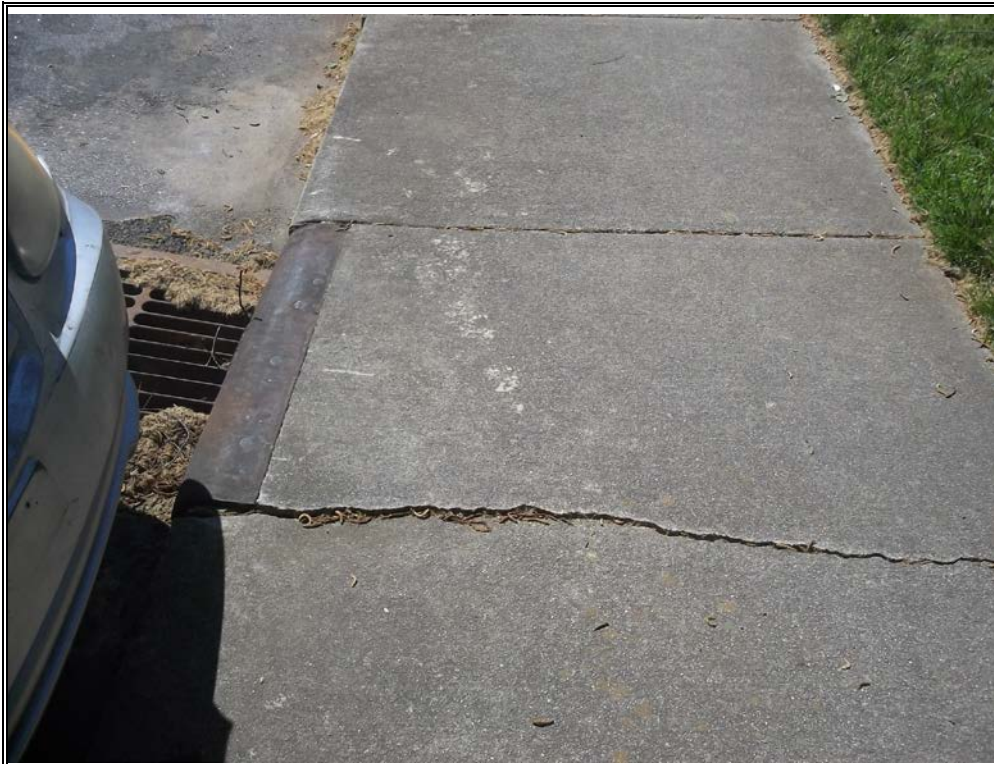
The association is responsible for maintaining the concrete flatwork consisting of the walkways and sidewalks and steps at the front of each building, along private streets, around dumpster enclosures and the concrete pool deck. We noted areas of moderate cracking and upheaval developing in sections of the concrete flatwork. We have allocated funds for periodic repairs and/or replacement of concrete surfaces as required and have assumed that 2.5% of the surfaces will require maintenance every 5 years beginning in 2017.

Example of cracking developing in concrete sidewalk.

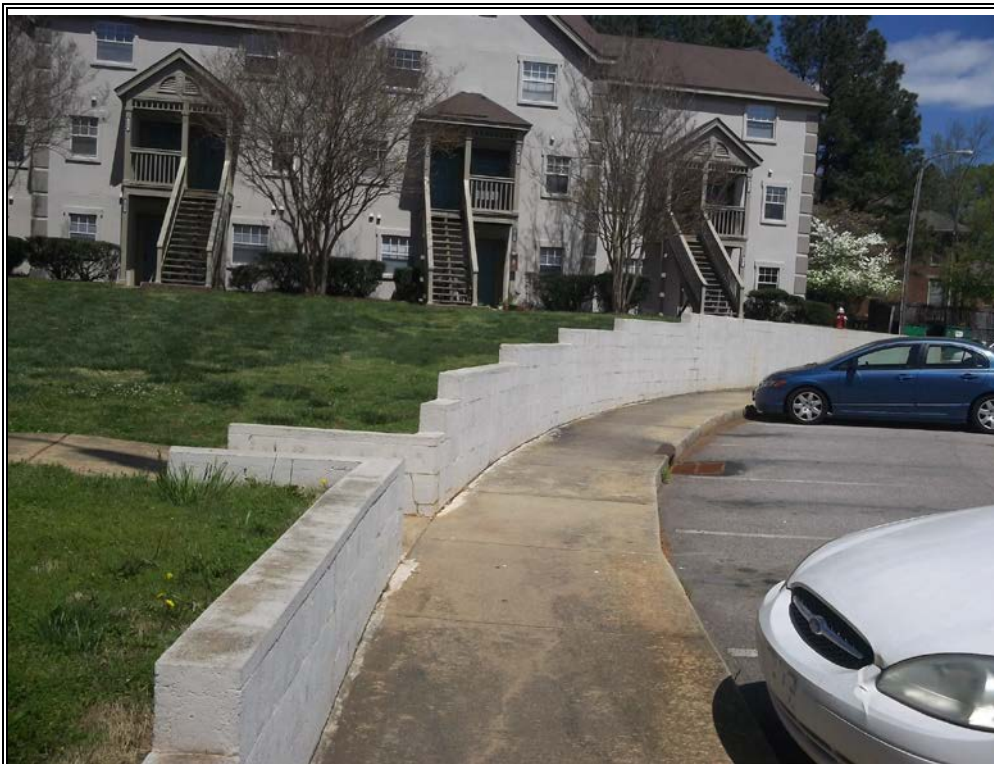
A concrete masonry unit (CMU) retaining wall is located along the parking area sidewalk in front of buildings 2510, 2512 and 2514. We noted minor cracking developing in sections of the retaining wall. We have allocated funds for full replacement of the retaining wall in 2032 in conjunction with asphalt paving resurfacing. Sections of the concrete sidewalk and paving will likely require removal to install appropriate geo-grid reinforcements or other tie-back systems. We strongly recommend closely monitoring the condition of the retaining walls for additional cracking/movement.

Description:
CMU retaining wall.

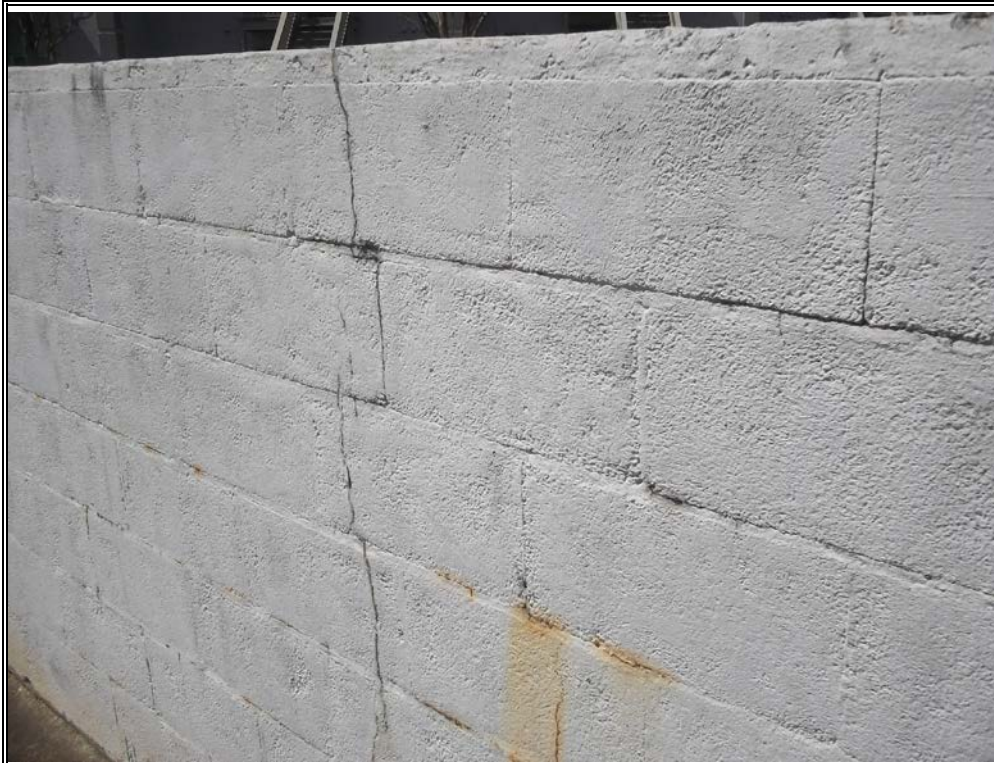
Photo Number
7

Description:
Minor cracking
developing in
retaining wall
sections.

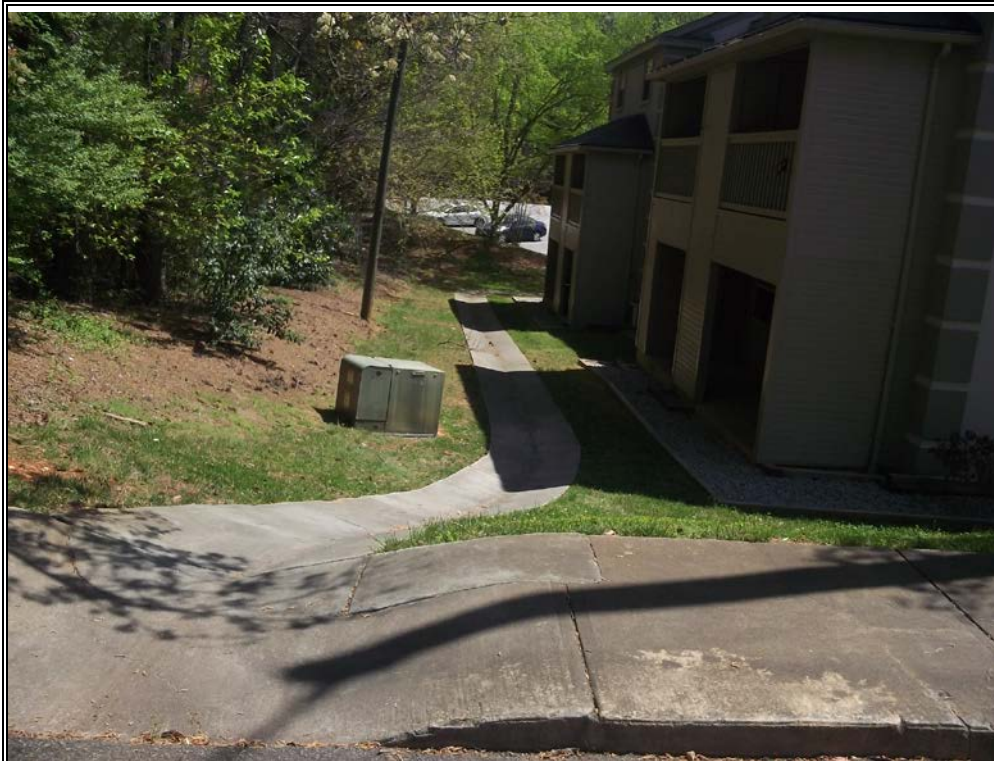
Photo Number
8

Description:
Concrete lined
drainage swale.

The swales tend to accumulate sediment that settles out during storm events and will need to be periodically removed and re-graded. In addition, over time, small landscape drainage systems will likely need to be installed in flat areas of the community to address concerns. We noted areas of erosion developing around the right side of building 2518 and the left side of building 2512. Soil erosion is beginning to undermine rear concrete patios in sections of the community, specifically observed at the building 2522. We also observed bare soils on embankments which can develop into erosion. We recommend maintaining adequate soil stabilizing ground cover to reduce erosion concerns. We also recommend having a portion of the private drainage infrastructure (buried piping) inspected with a video borescope system, flushed, and repaired as necessary. We have allocated funds to repair the drainage systems on a 5 year cycle beginning in 2017. Repairs will likely include retrenching of swales to improve flow, adding rip rap or vegetation to stabilize exposed or steep areas, repairing erosion concerns, extending gutter downspouts to underground systems, installing french drains or other types of minor drainage systems.

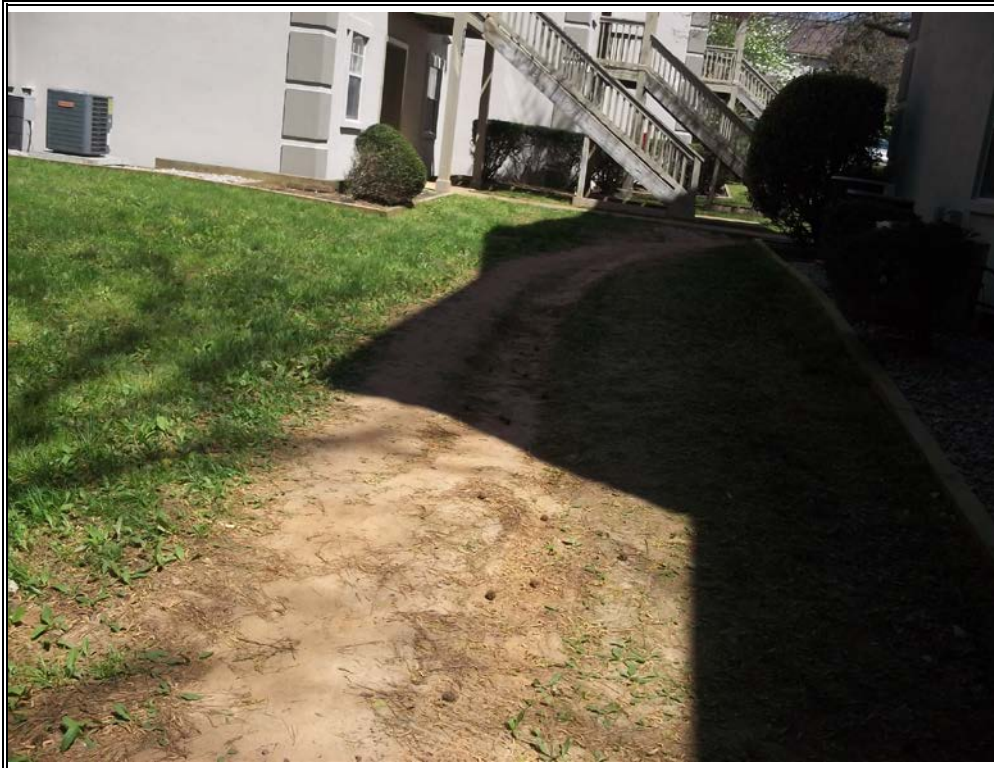
Photo Number
9

Description:
Soil erosion
developing in
common areas.

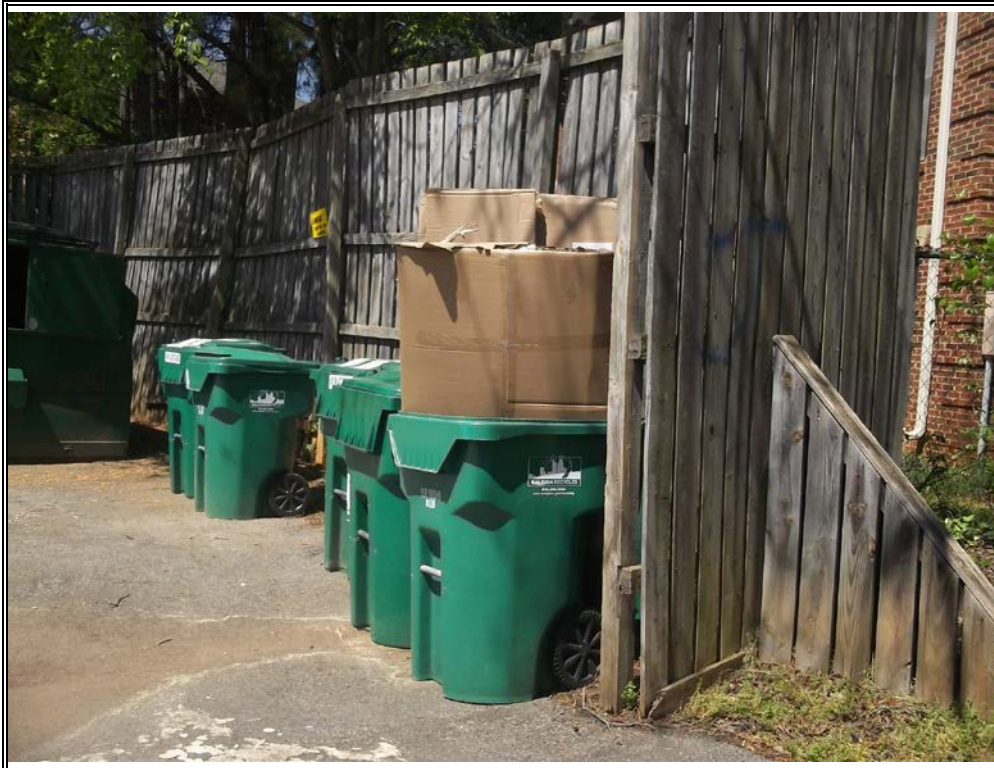
Photo Number
11

Wood fencing is installed around a dumpster area in the community. The wood fencing was observed to be in poor condition and is leaning significantly. We have allocated funds to replace the wood fencing at the dumpster enclosure on a 15 year cycle beginning in 2017.

Description:
Wood fencing at
dumpster area.

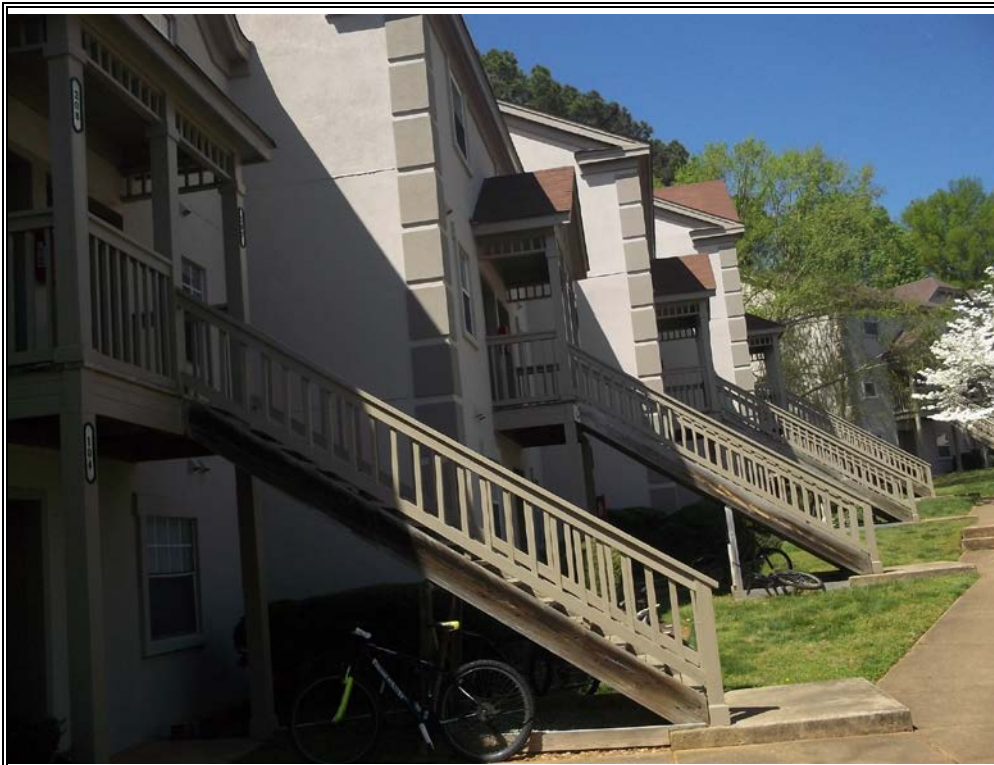
Photo Number
12

The condominium buildings include wood framed stairs and front porches to access the front entry of the units. The wood framed stairs and porches appeared to be in fair condition and will likely require significant repairs/replacement in the near term. The front porch structures do not include lateral bracing as required in current code and the front porch structures do not appear to be adequately through-bolted to the building as required by current code.

Description:
Typical front view
of buildings, wood
framed front
porches/steps.

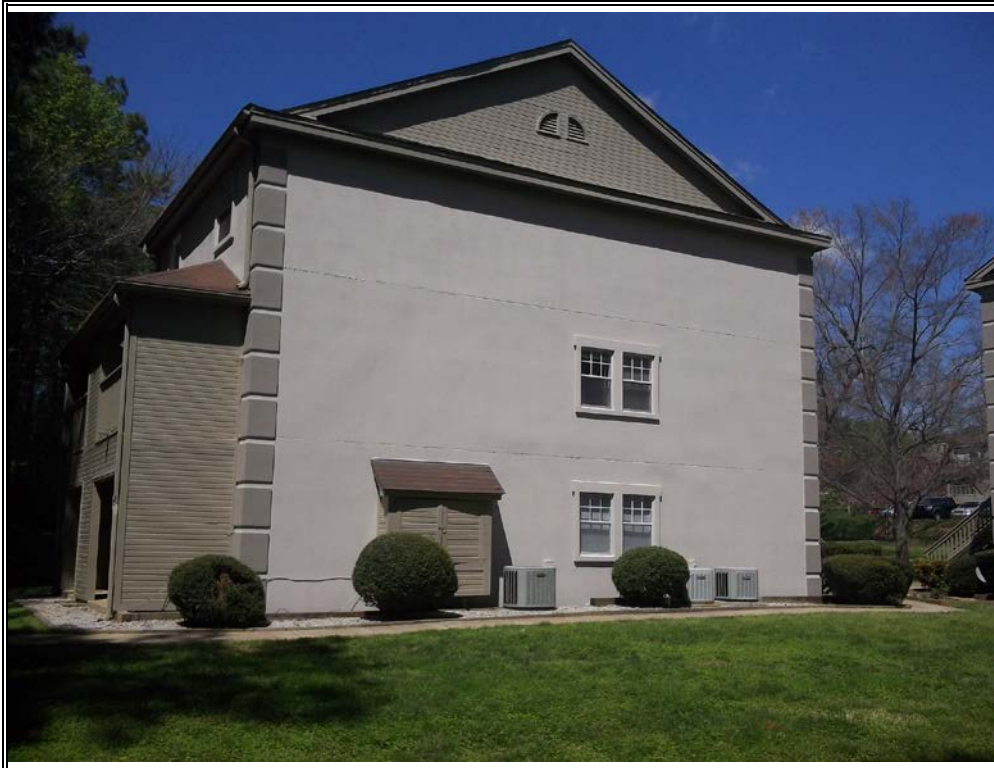
Photo Number
13

The buildings throughout the community are predominately clad in an EIFS (exterior insulation finishing system) stucco cladding. Sections of the building include painted wood siding and trim. The exterior surfaces of the buildings generally appeared to be in good condition and recently repaired and painted. We have allocated funds for painting and repairs of the EIFS, wood siding and trim components on all of the buildings on an 8 year cycle beginning in 2023. The painting/repair cycles should include repairing/replacing damaged sections of siding and trim, repairing deteriorated caulking and flashing, a thorough cleaning and proper surface preparations and the application of 2 coats of a high quality exterior grade paint.

Description:
Side view of
buildings, EIFS
and wood siding.

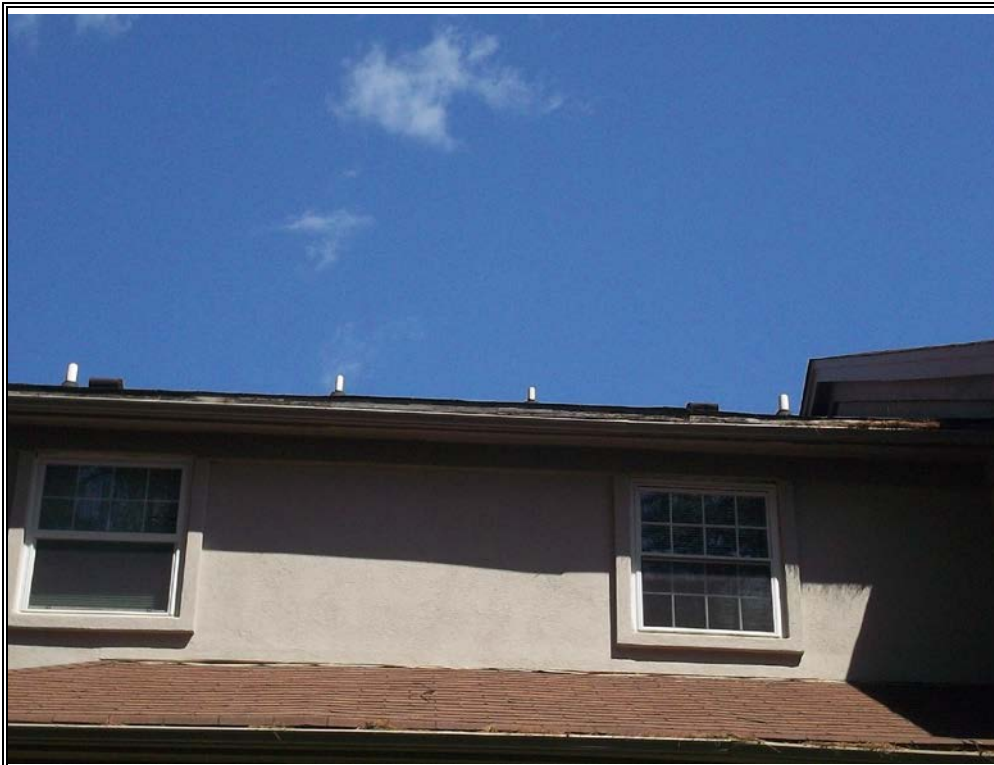
Photo Number
14

The predominant pitched roof surfaces over the buildings are covered in asphaltic fiberglass shingles. Roof surfacing is applied over plywood roof sheathing, and generally appears to be in good condition. The roofs throughout the community appear to have been replaced approximately 10 to 15 years ago. We are unaware of any concerns with current roof leaks. We anticipate minor improvements including replacing vent boots, flashing and drip edge repairs, and gutter repairs will begin to be required in the near term. We have assumed minor repairs would be funded from an annual maintenance budget.

Gutters and downspouts are in generally good condition and should not require replacement until the time of roof replacement, as this component typically provides twenty years of relatively trouble free service. Note that we observed gutters filled with debris and possible fascia damage on the rear face of building 2514. We have assumed this repair and similar periodic repairs and gutter cleaning would be funded from an annual maintenance budget.

Description:
Building roofs and
gutters.

This type of roofing has an expected useful life of approximately 20 years. We strongly recommend that any re-roofing project closely follow procedures outlined by the National Roofing Contractors Association's *Roofing and Waterproofing Manual*. A re-roofing sequence should include removal of the existing roofing material, replacement of any inadequate roof sheathing, replacement of any damaged flashing, and replacement of drip edge components. We have allocated funds to replace the roofs on all of the buildings in 2024.

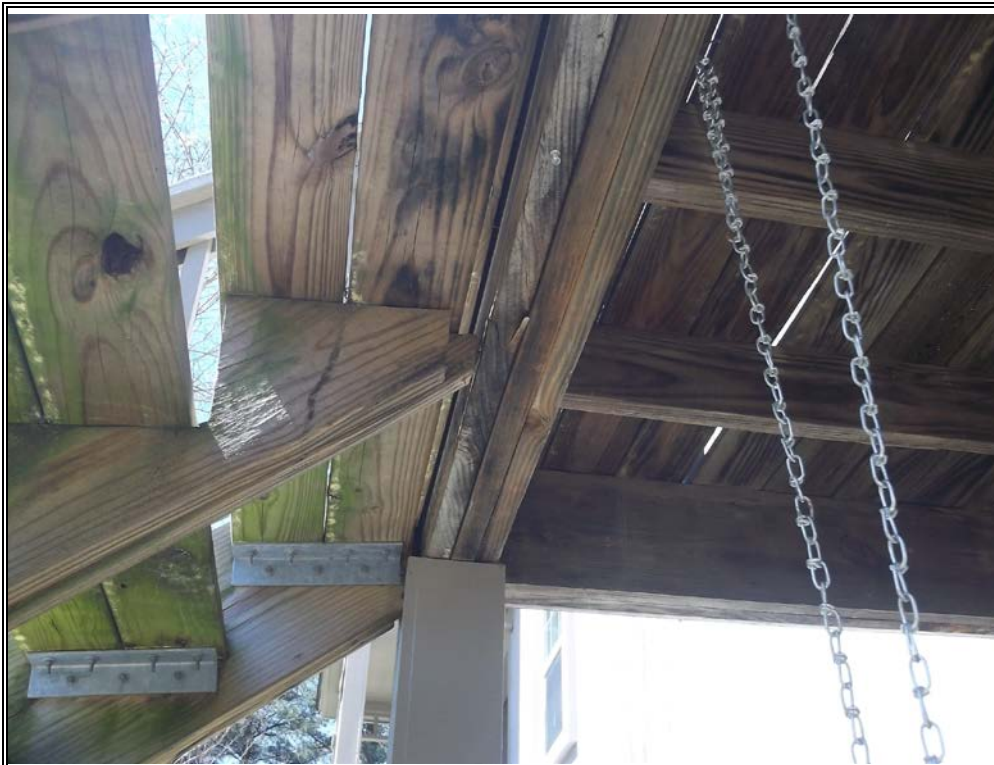
Photo Number
16

We noted relatively minor immediate repair needs for the front steps including the repair of a central stair stringer in front of unit 2510-204. The center stair stringer at this location does not appear to be adequately fastened to the girder. We strongly recommend periodic inspections and repairs be completed to the front porch/stair structures. We have allocated funds to completely rebuild the front porch and stair structures in 2020. This would include replacing posts, footings, structural framing, decking and railings. We have assumed the front porch roof structures would be able to be temporarily supported during construction and not require replacement.

Description:
Close up view of
framing at front
porch steps, center
stringer not
adequately
attached at unit
2510-204.

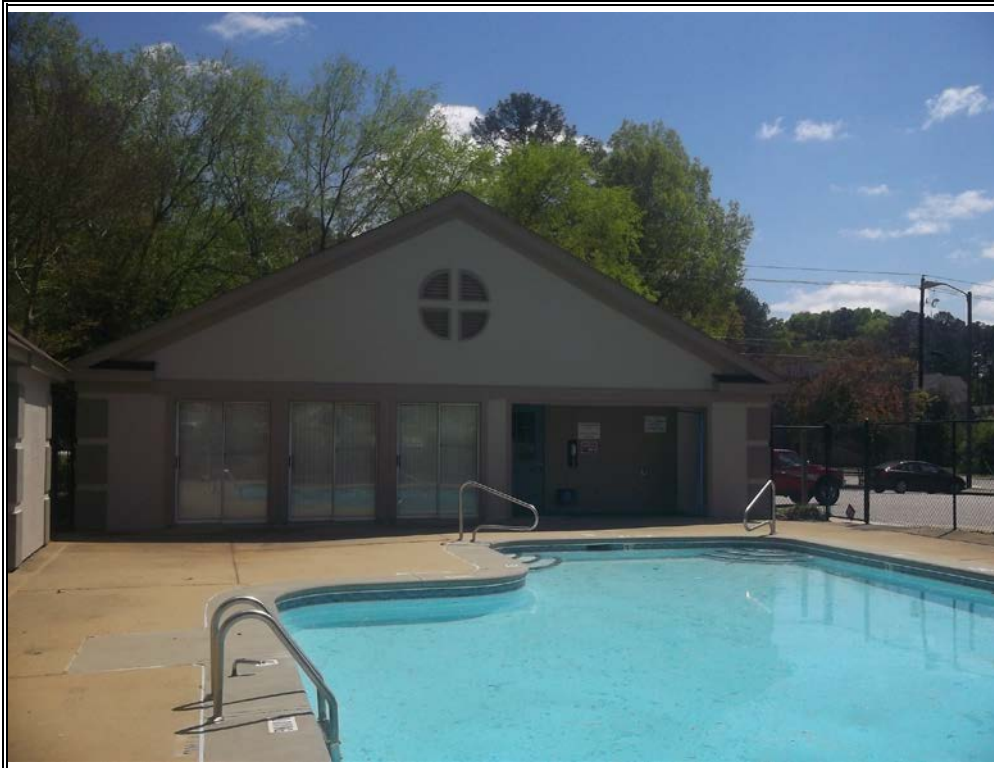
Photo Number
17

The clubhouse building includes sliding glass doors, personnel doors and windows. The doors and windows at the clubhouse building appeared to be in fair to poor condition and of original construction. Several windows were observed with broken panes that have been repaired. We have allocated funds to replace the doors and windows at the clubhouse on a 30 year cycle beginning in 2017.

Description:
Swimming pool,
clubhouse building
sliding glass doors.

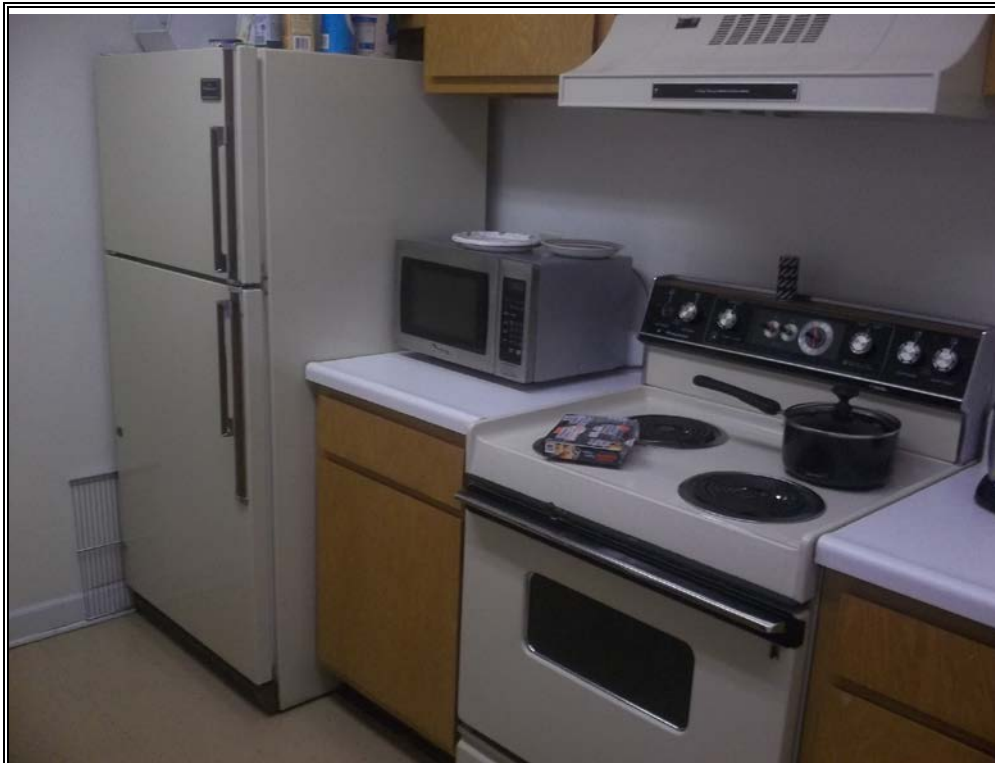
Photo Number
20

The kitchen cabinets, counter tops and appliances appeared to be of original construction. We have allocated funds to refurbish the kitchen cabinets and counter tops on a 25 year cycle beginning in 2019. We have allocated funds to replace the appliances in the kitchen on a 15 year cycle beginning in 2019.

Description:
Clubhouse kitchen
cabinets and
appliances.

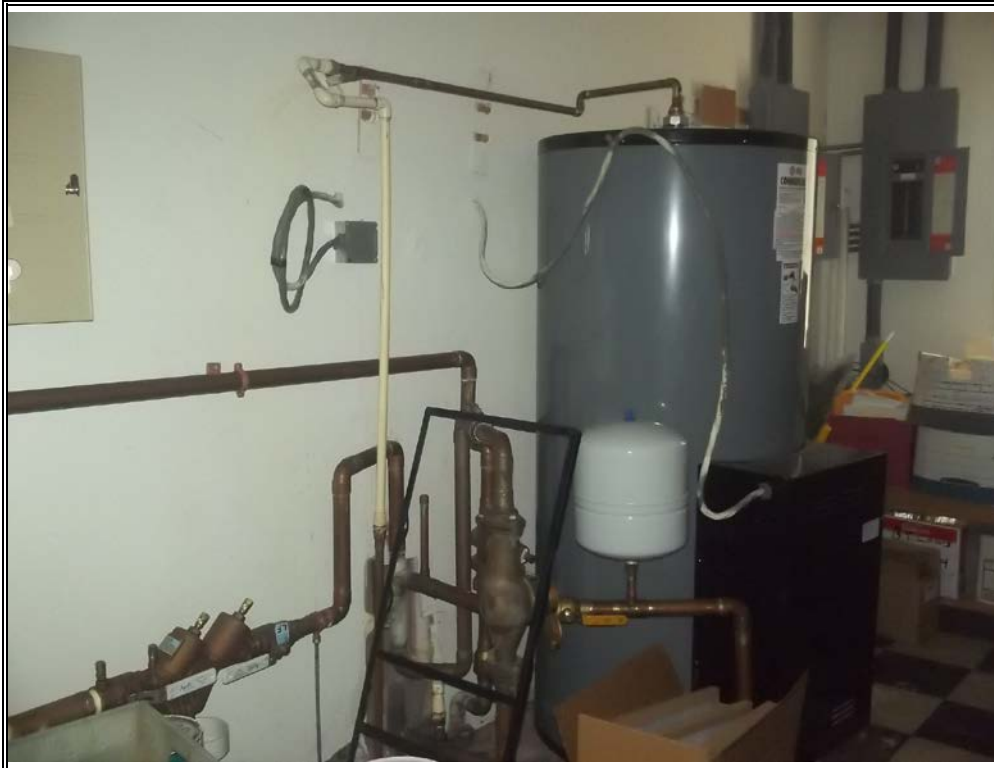
Photo Number
21

A laundry room with leased equipment is located in the clubhouse building. The water heater serving the clubhouse is a Rheem manufactured 120 gallon electric water heater manufactured in 2010. Water heaters typically have an expected useful life of approximately 15 years. We have provided an allocation of funds to replace the water heater in 2025.

Description:
Water heater and
piping in
clubhouse.

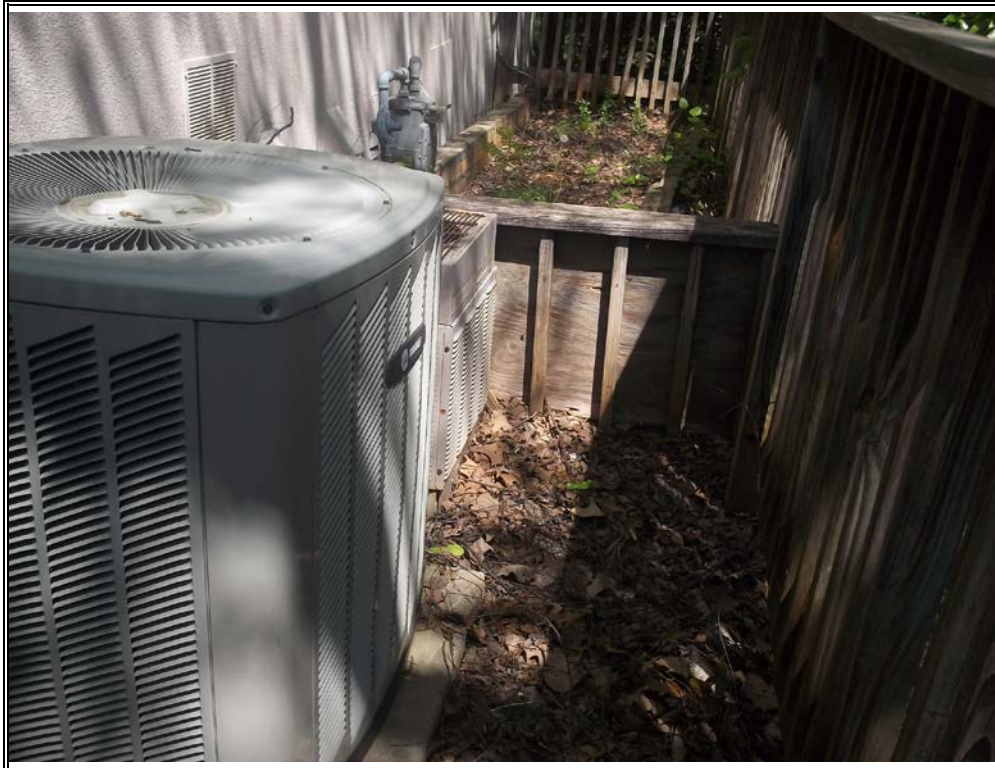
Photo Number
23

The clubhouse is served by a Trane 1.5 –ton capacity and 4-ton capacity, split-system heat pump units that were manufactured in 1984 and 2003. The interior fan coil units appear to be of original construction (1984). We have provided funds to replace the HVAC system at the clubhouse on a 15-year cycle beginning in 2017 for the older equipment and in 2024 for remaining equipment.

Description:
Heat pumps
serving the
clubhouse
building.

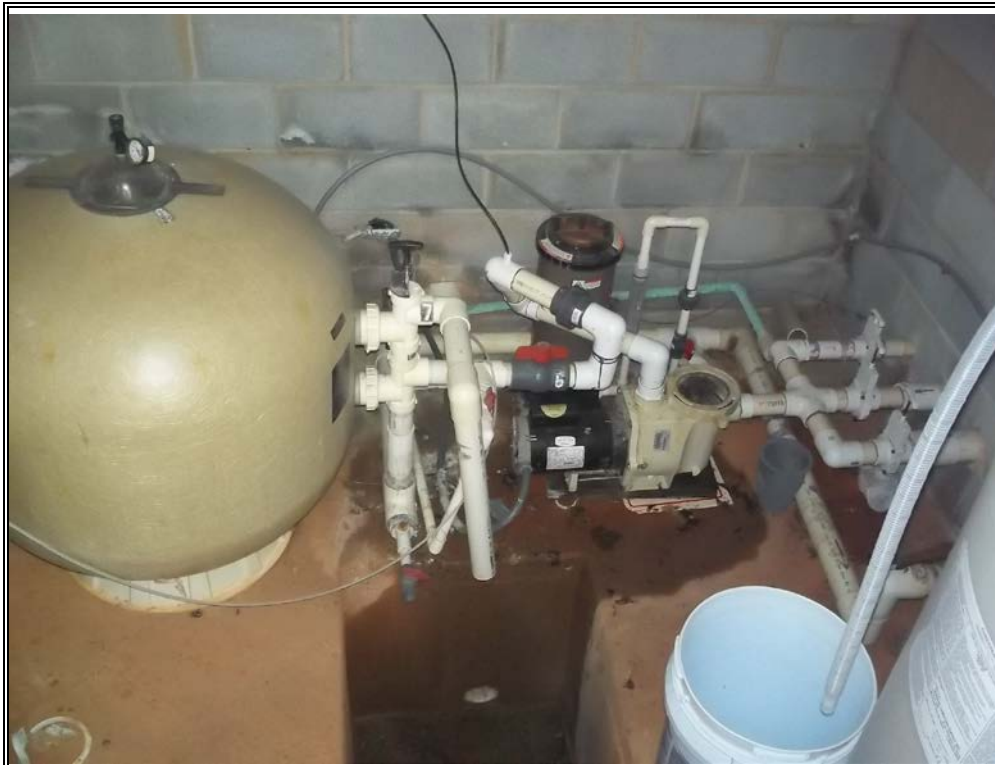
Photo Number
24

The pool pump and filtration equipment located pool building consists of a 2-horsepower pump with a Triton II sand filter and an auto-chlorinator system. These items are typically replaced as they fail, and we have provided funds to replace components of the pump and filtration system on a 3 year cycle beginning in 2017. Repairs will likely include replacing pump and/or motor, replacing sand in the sand filter and other repairs.

Description:
Pool pump and
filtration
equipment.
